# **Environmental Impact Assessment: Maddox Creek Culvert Removal and Habitat Restoration Project**

**ESCI 493 Winter 2017**

**Huxley College of the Environment  
Western Washington University**

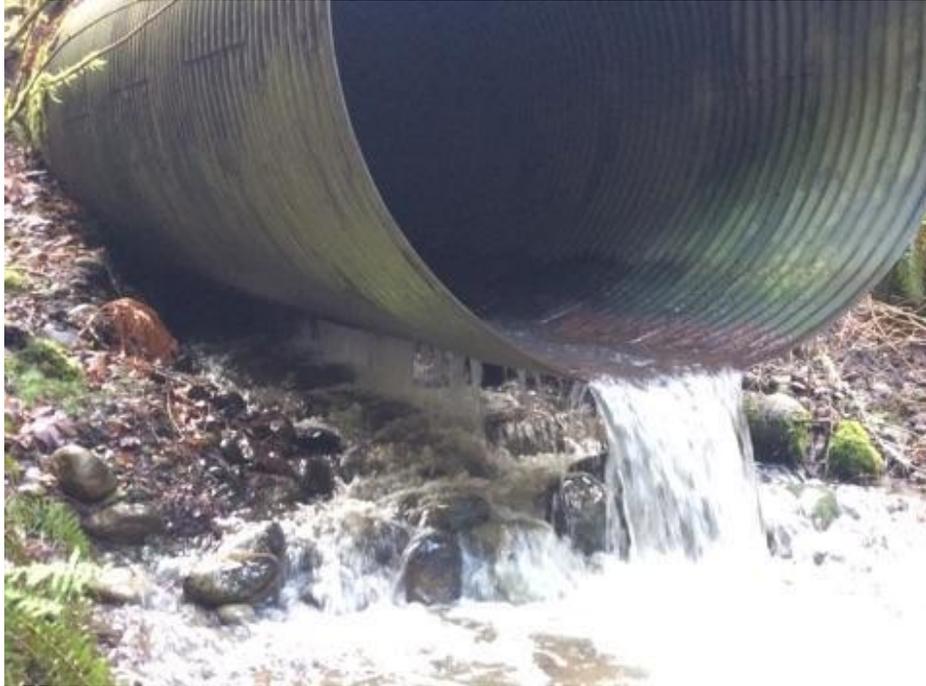
Currently the culvert is failing and portions of the bottom of the culvert are completely rusted out, with water flowing beneath the culvert in those areas. A portion of the top of the culvert is caving in. Water can be clearly seen coming out from underneath the culvert at the outlet end. Also the water at the inlet end is trying to carve its path next to the culvert, cutting away at the bank and creating a whirlpool before entering the mouth of the culvert.

Figure 2. Water seeping from the rusting culvert bottom.

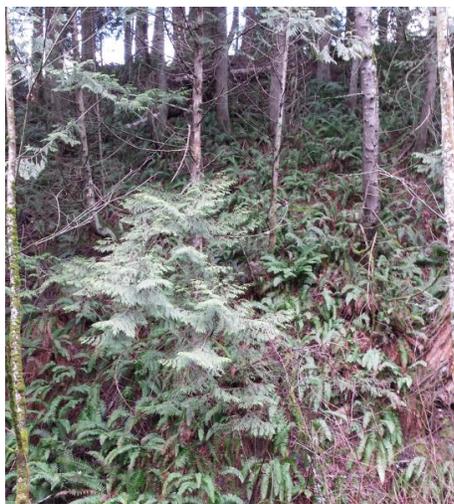
Maddox creek flows along a ravine at a steep gradient (2%<) in the drainage sub-basin between steep woodland hillslopes. The clay fill overlying the culvert exhibits steep slopes upstream and downstream descending to the culvert. The dominant soil type at the site, Hoogdal silt loam, is characterized by slope gradients of 30-60% and elevation ranging from 100 to 300 feet (USDA, *Web Soil Survey, n.d.*). Coniferous trees growing on the hillslopes are bending upslope, indicating that the hillslopes are creeping and not stable.

Figure 6. Steep woodland hillside, facing the right bank directly downstream of the culvert.

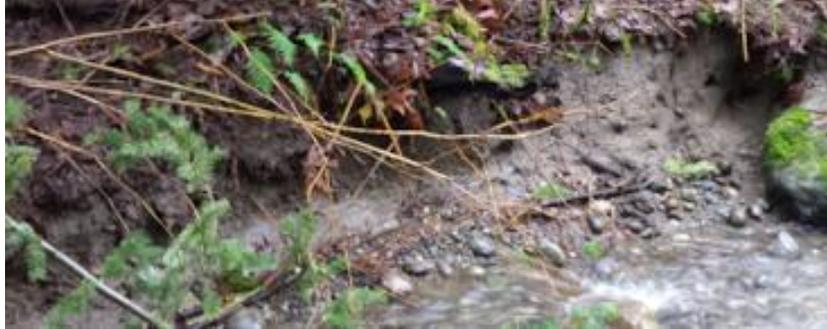
The streambanks are classified as moderately unstable, with minor erosion, bank undercutting, and scalloping of banks (City of Mt. Vernon, 2008). The increased input of stormwater runoff from urbanization has magnified erosion of the streambanks, streambed, and clay fill. There is a stream of water from overland flow draining down the clay fill slope and eroding the clay fill.

Figure 7. An undercut streambank to the left of the culvert inlet, where backwater pools during high flows, and erodes the streambank.

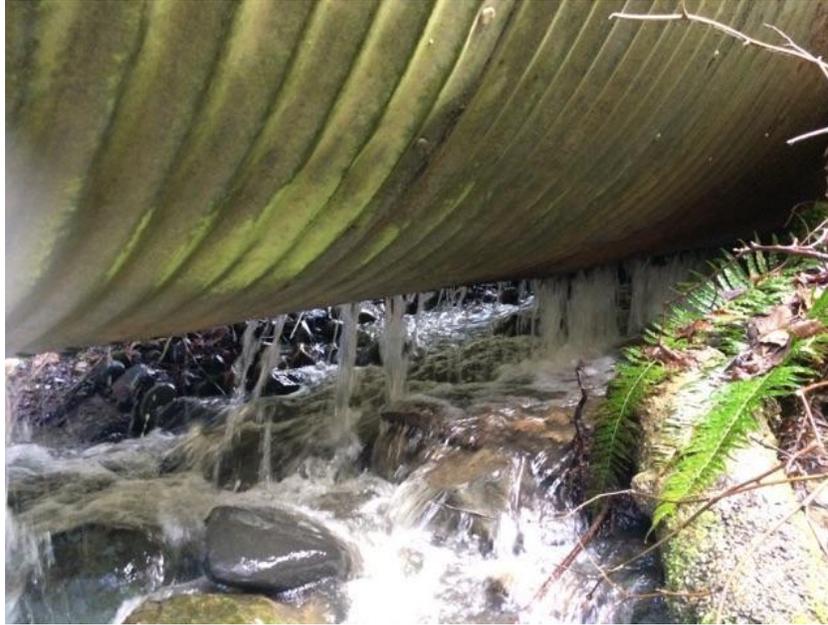
Flooding has not been an issue despite the size of the culvert for the water flow of Maddox Creek and the depth of the ravine, although fast moving water in the culvert has led to significant erosion of the 6-ft diameter pipe on the bottom. Water leaking through the eroded portions of the culvert is moving under the culvert, eroding what the culvert is setting on. Water can be clearly seen coming out of the ground underneath the culvert on the outlet end. The culvert is also collapsing in on itself in one area. These factors will be addressed in the no action alternative and how they will affect flooding.

Figure 8. Water spilling out from the deteriorating culverts bottom, eroding the fill material below the pipe.

The proposed action of removing the culvert and daylighting the stream will, in the long term, only reduce flood risk. Since flooding will likely only occur in the event of a failing culvert, restoring this portion of the channel to its original state will decrease the risk of flooding tremendously. Although, during the construction period some riparian vegetation may be removed or trampled causing increased surface runoff for a short period of time.
