## Fiberglass Composite Repairs Presentation

# Fiberglass Composite Repairs

Brad Fenbert, along with Ian Saksa  
Project Adviser: Dr. Tanveer Chawla

Problem: Determination of fiberglass composite repair factors that affect crack propagation fracture toughness.

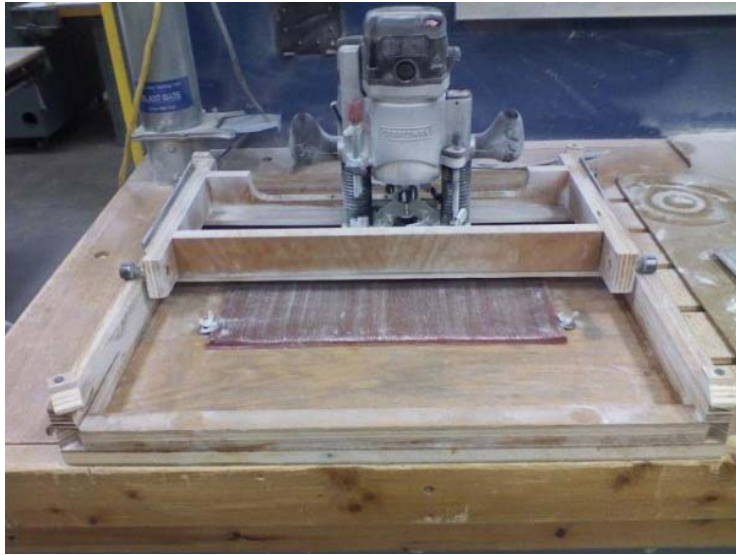
Figure 6. Grinding Setup

- Table frequently got stuck
- Grind depth would surpass router setting
- Table deflected in the middle
- Table accommodated 15.75" plates
- Relied on visual cues

- More consistent process, change apparatus so it doesn't deflect

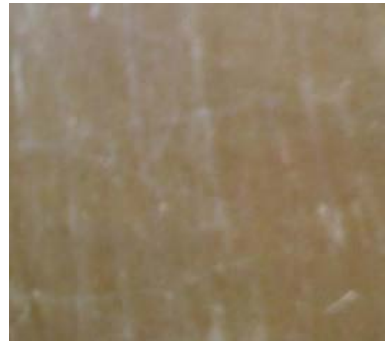
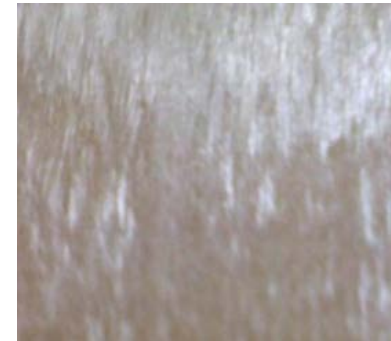
Figure 7. Full (left) vs half grind (right) surfaces

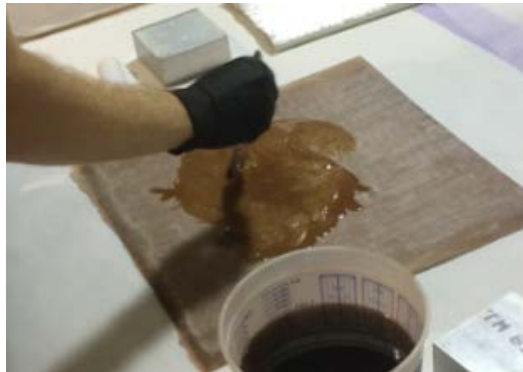
Figure 8. Cleaning plate surface

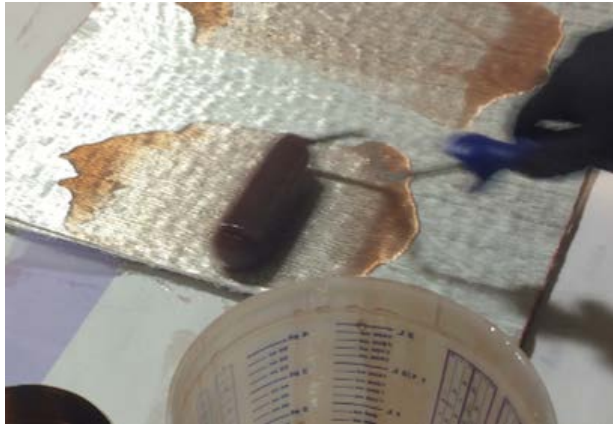
Figure 10. Foam roller for resin

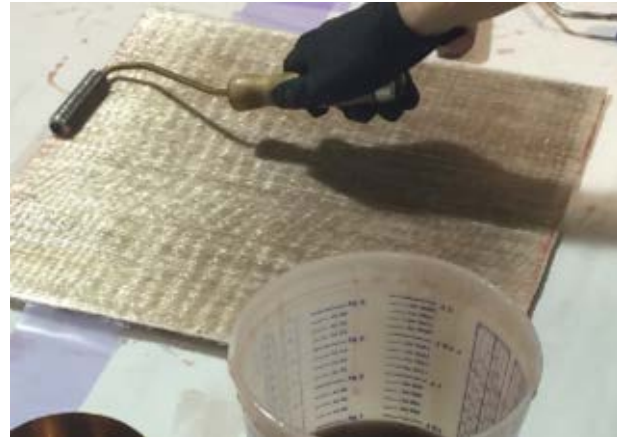
Figure 11. Metal roller for smoothing sheets

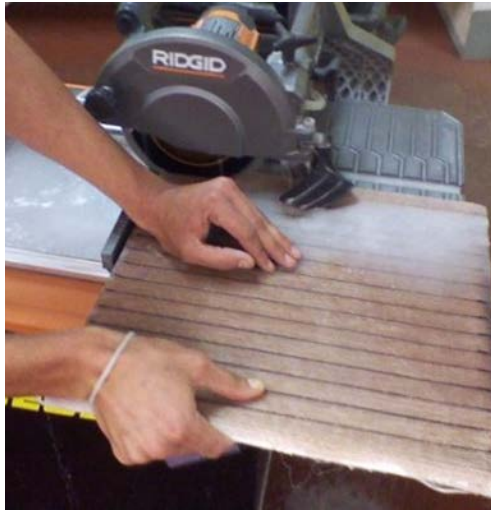
Figure 12. Cutting out specimens

- Table saw did not cut straight, laser alignment was off
- Difficult to cut hinges straight

- Straighter cutting device, such as the water jet
- Wider specimens, help improve bonding surface area between hinges and specimens
- Less white out, make sure it does not flake
- More speckles at load point to allow for easier Vic 2d analysis

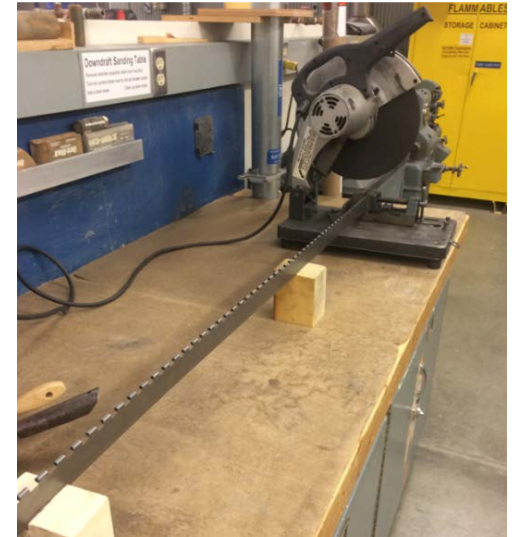
Figure 13. Cutting out hinges

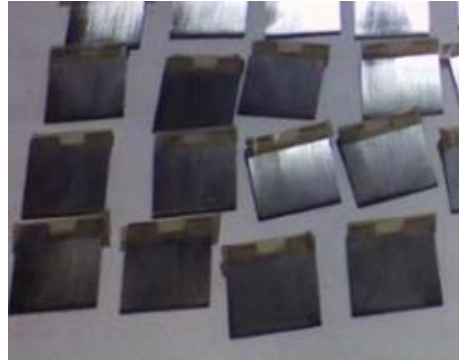
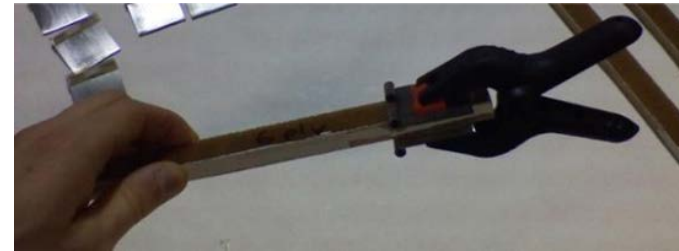
- Hinges were grinded, and teflon tape was added to allow consistent/even adhesive bonding surface
- Specimens were marked with white out and marked with fine tip ink pen marks to aid crack propagation/displacement measuring
- Hinges were adhered with methacrylate adhesive (Plexus MA300)

Figure 16. Hinge held by clamp

Figure 14. Roughed hinge surface

Figure 15. Teflon tape on hinges

- Less teflon tape, although allowed smoother adhesion, didn't provide bond strength in critical area at load point, where hinges failed
- Stronger hinge adhesion, either resin or surface preparation of specimens

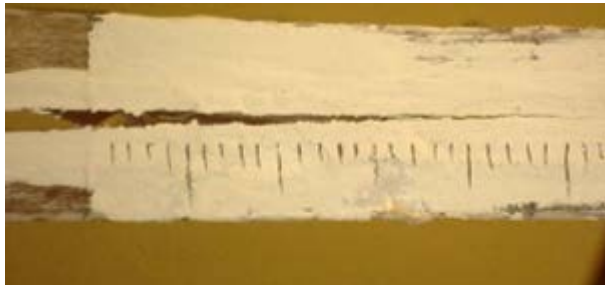
Figure 21. Crack length

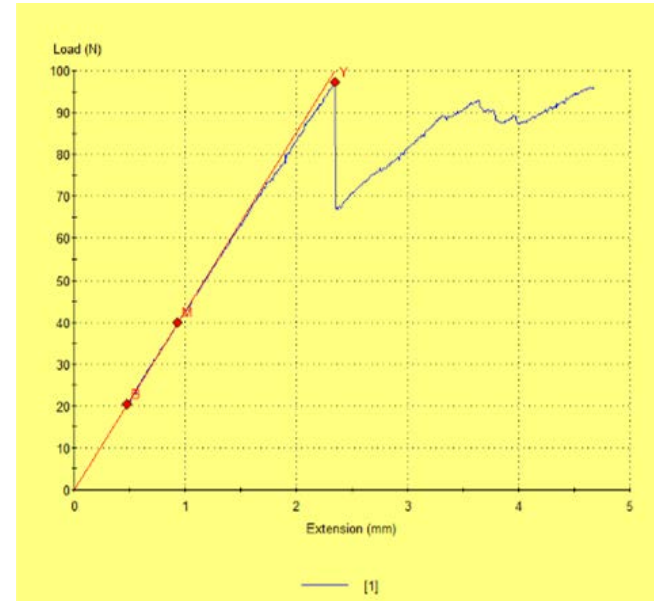
Figure 22. Applied load

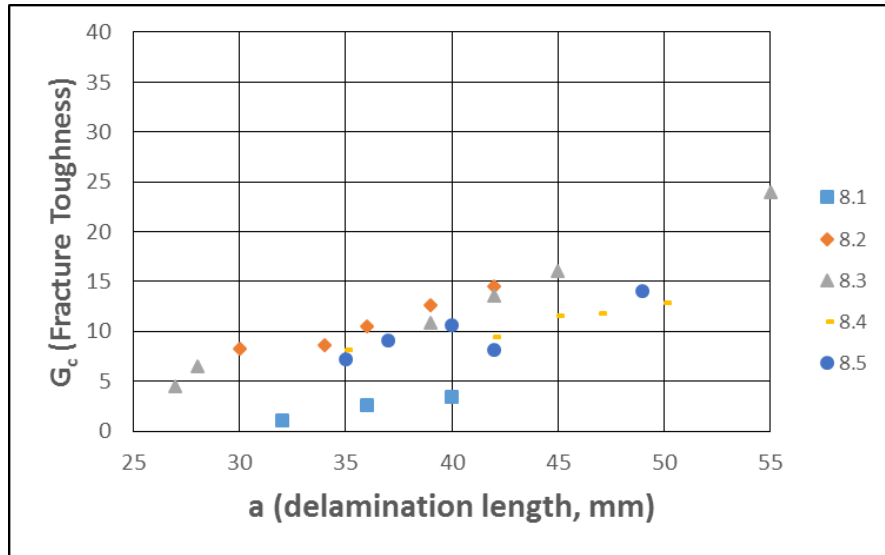
Figure 28. Plate 8 (**full grind**, csm, vinyl ester)\*

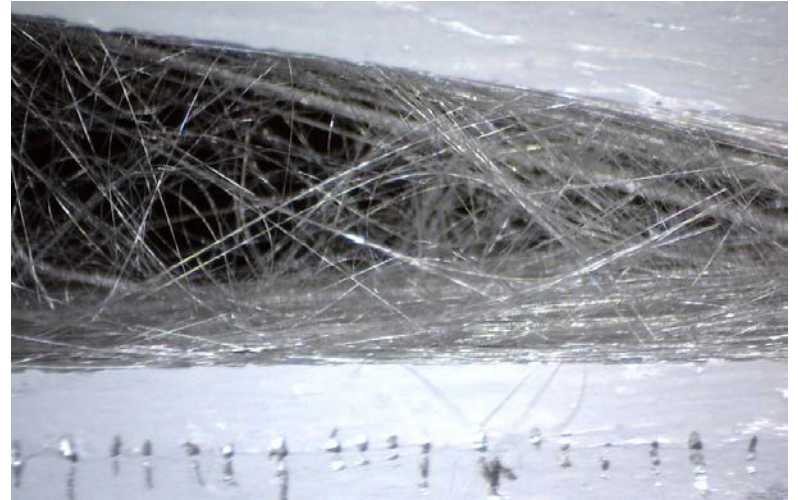
- Factors increased the amount of fiber bridging

Figure 34. Fiber bridging in Plate 5 (full grind, polyester) vs Plate 3 ( $\frac{1}{2}$  grind, vinyl ester)
