WWU Honors Program Senior Projects

Sehome Hill Arboretum Trail Decommissioning Follow Up

Sehome Hill Arboretum Trail Decommissioning Follow Up
WWU Honors Senior Project
Calvin Heslop
May 2016

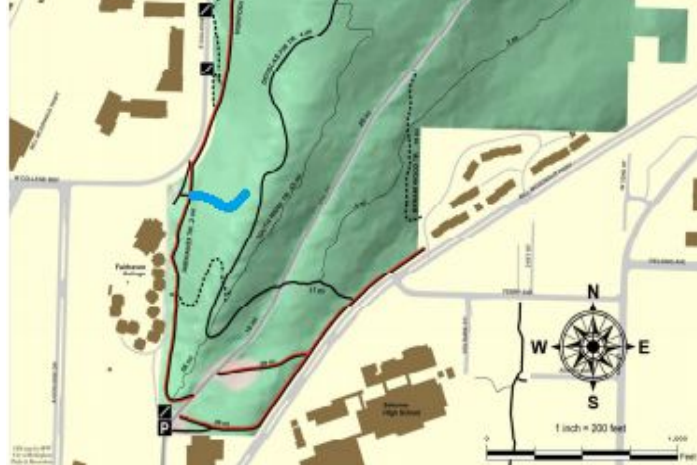
Figure 1. The southern portion of Sehome Arboretum in Bellingham, WA. The blue line represents the approximate location of the social trail.

During September of 2015 four classmates and I planned and executed a decommissioning and restoration project of a social trail in the Sehome Hill Arboretum. The social trail we decommissioned is immediately adjacent to the north Fairhaven entrance to the Hontoon Trail (Figure 1). The trail connects the Hontoon Trail to another social trail that then connects to the Douglas Fir Trail. The social trail's entrance is partially obscured where it connects to the Hontoon Trail but very obvious where it meets the upper social trail. We suspected that many users enter from the top before realizing the trail is unofficial. The trail is approximately 90 meters long and about a meter wide. The trail has a maximum slope of about 39° with evident erosion on the steep portions (Allen et al. 2015).
