Mechanical Testing of Artificial Muscles

Senior Project Implementation 2014

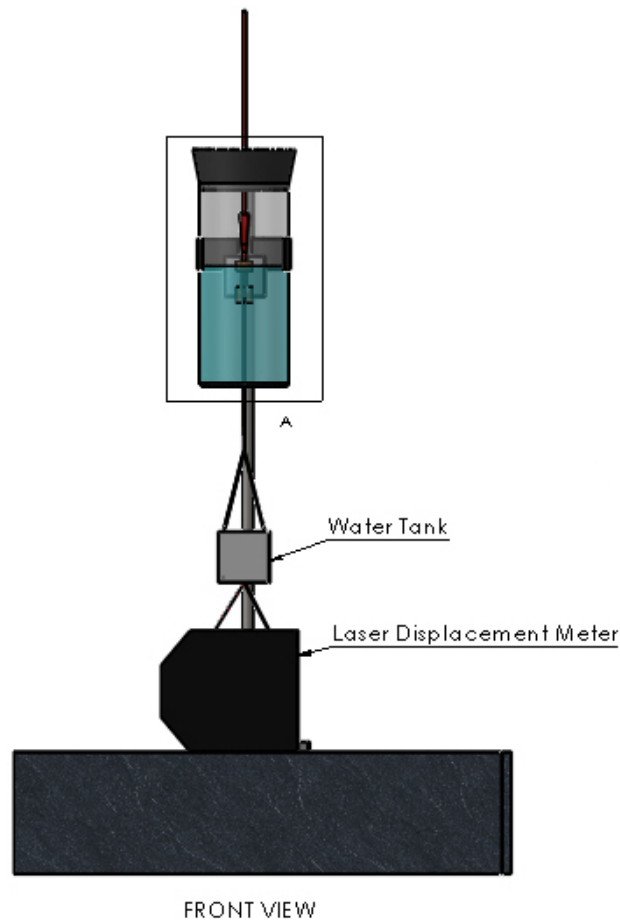
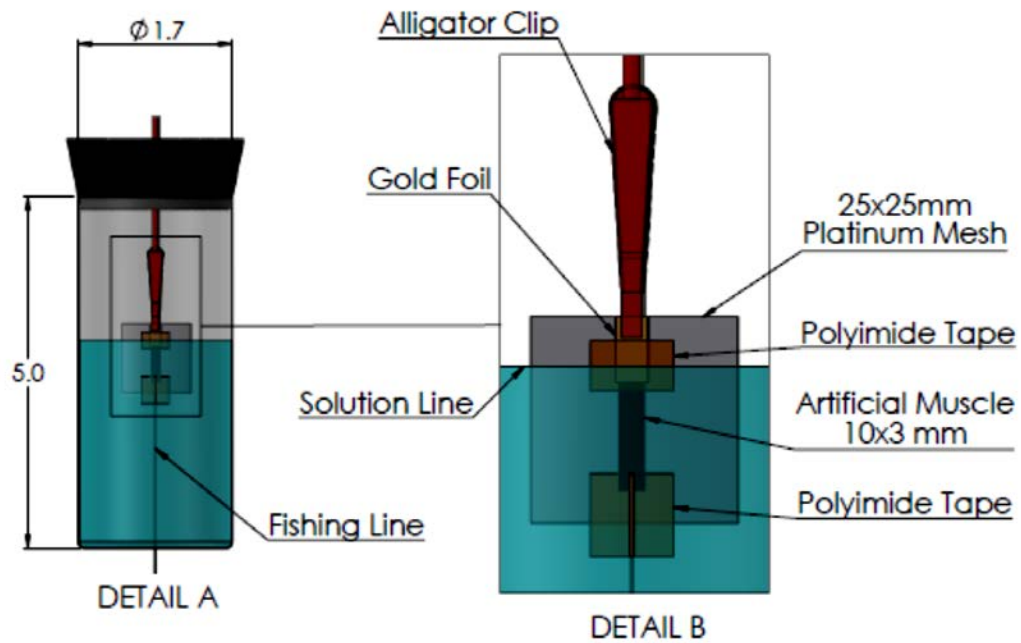
Figure 1: Front view of proposed solution design with close-up views of cell (Detail A) and artificial muscle assembly within cell (Detail B). Includes proposed minimum dimensions of cell and solution line.

The plastic container is clamped in a three prong clamp attached to a clamp stand. The laser displacement meter is positioned directly below the cell and hanging water tank in order to measure the movement of the artificial muscle. Schematics of this proposed design can be seen below in Figures 1 and 2.

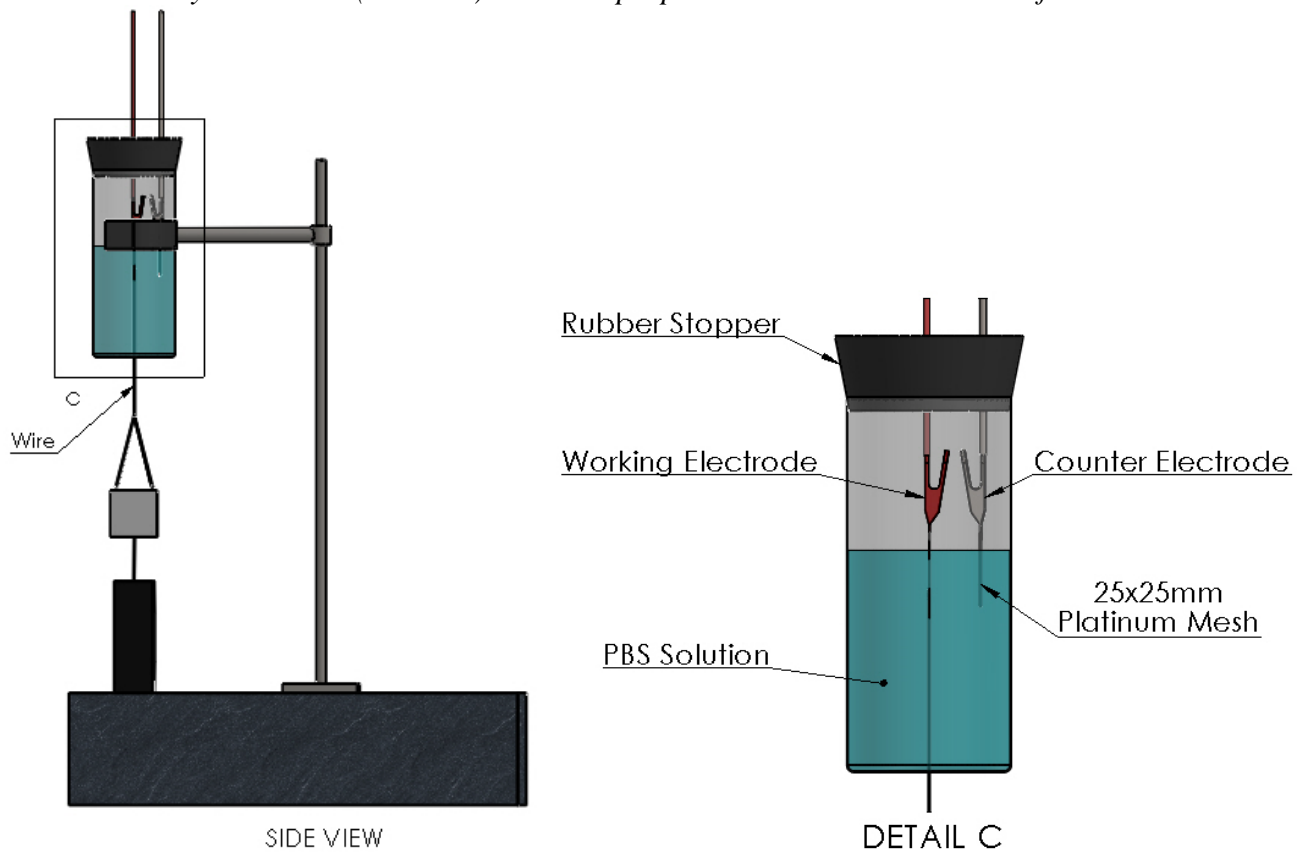
Figure 2: Side view of proposed solution design with close-up detail of cell (Detail C).

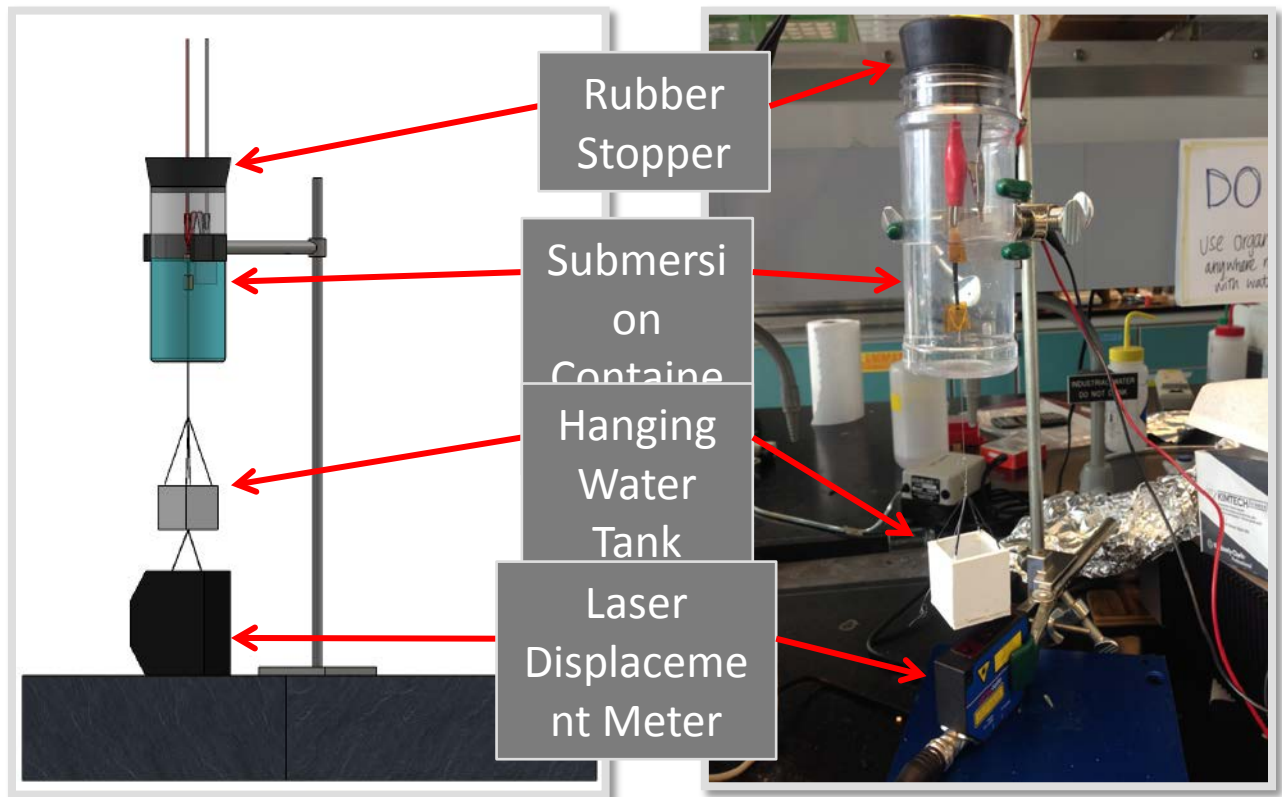
Figure 3: Proposed instrument design (left) compared to actual instrument (right)

A picture of the fully assembled strain testing instrument that was built for this project in comparison to the proposed design can be seen in Figure 3. As can be seen in these pictures, the instrument looks very similar to the design. Aside from a few minor modifications (to be explained), the proposed design was successful and functioned as expected. Figure 4 shows a close up view of the submersion container. The kapton tape successfully secured both ends of the actuator, the fishing line suspended the hanging water tank directly below the strip passing through the pinhole, and the rubber stopper provided an air tight seal to prevent the PBS solution from leaking through the pinhole. The electrode leads attached to alligator clips were adjustable thanks to the use of non-permanent sealant tape. This meant that the fill line of the PBS solution could be a general estimate instead of a precise height, and also allowed for varied lengths of strips and gold foil to be usable in this set up.

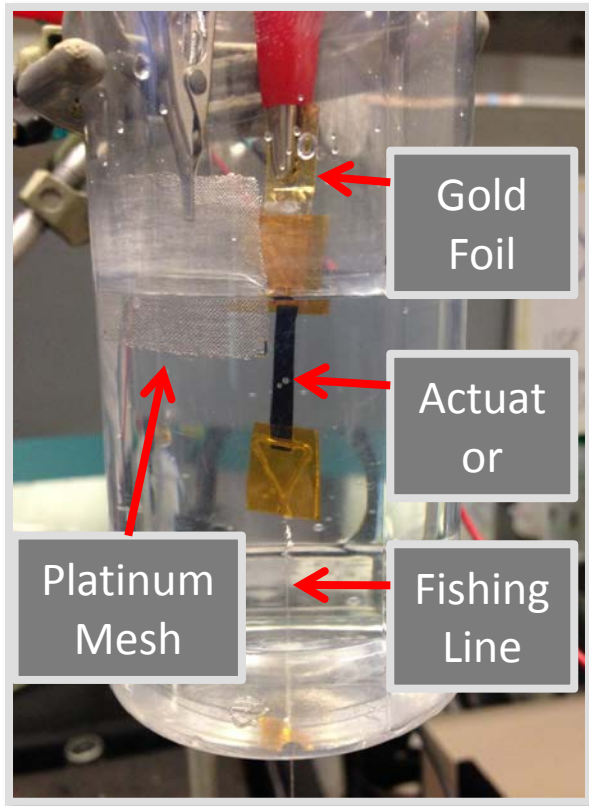
Figure 4: Close up of submersion container

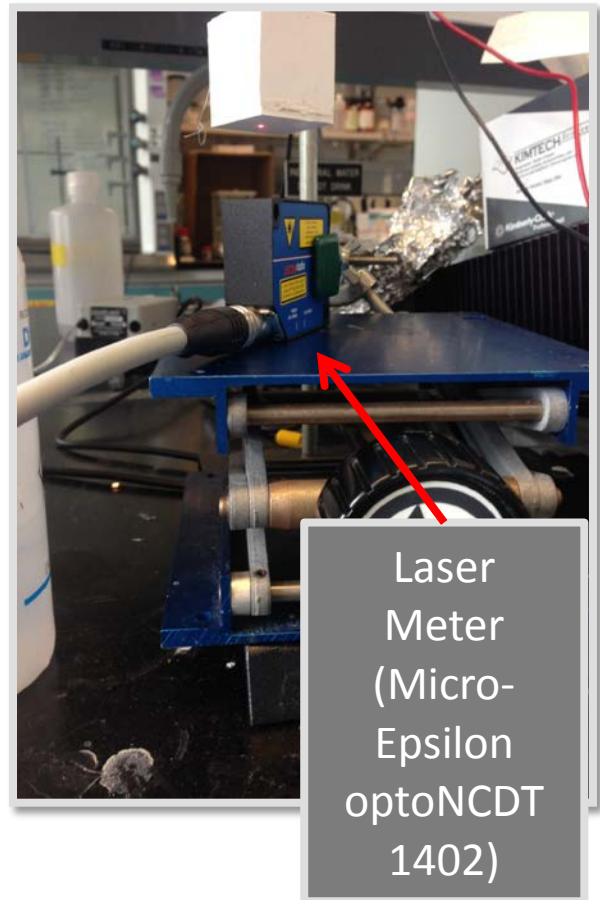
Figure 5: Close up of laser displacement meter positioned on lab jack and referencing water tank

Figure 5 shows a close up view of the laser displacement meter secured on the surface of the lab jack and referencing the base of the hanging water tank. The hanging water tank weighed approximately 12 g, and with the addition of approximately 8 g of water, a load of approximately 0.2 N could be applied to the strip, similar to the force generation testing. The water tank would often swing a bit after being attached to the fishing line, and was stabilized by holding an object such as forceps or a clamp near it prior to data collection. The laser displacement meter, after adjusting the height of the lab jack in order for the laser to be at the top of its range, was securely clamped in place with a clamp attached to the stand holding the submersion container. This helped to improve the consistency of the measurements by preventing noise caused by movement near the laser. Utilizing the lab jack to adjust the height of the laser in respect to the water tank is much easier than securing the laser to the counter top and adjusting the height of the rest of the instrument.

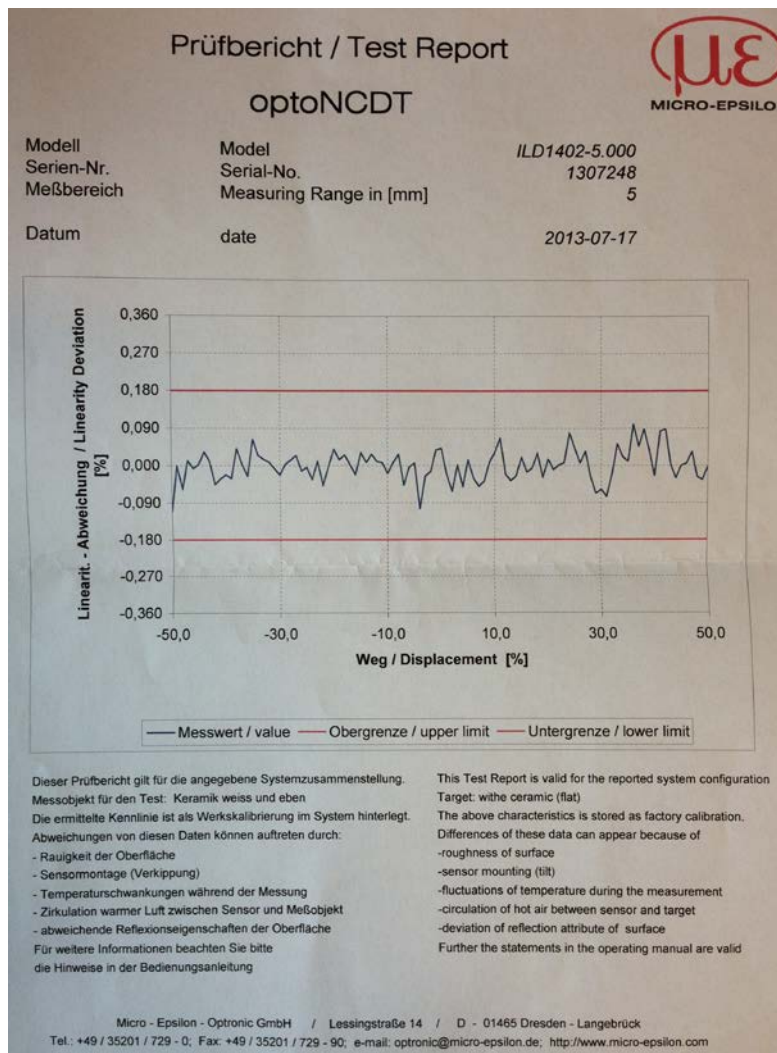
Figure 6: Control chart sent by Micro-Epsilon showing laser was calibrated and within linearity control limits of $\pm 0.180\%$

Figure 6 is a picture of the control chart sent by Micro-Epsilon showing that the laser was calibrated and within linearity control limits. This means that the measurements the laser makes are highly accurate, within 0.180% of the actual value. Since the movements of the actuator strip are so minor, this accuracy is very important. The laser has an accuracy of 0.6 μm [12] which surpasses the requirement for a measurement system with an accuracy of 10-1 μm . This confidence in the measurement device would not have been as strong if a laser had been purchased used. Another great feature of the Micro-Epsilon laser displacement meter that was purchased for this project is the measurement software program that it came with. Figure 7 shows a screen shot of the software program. The software not only shows the laser's current measurement, but also collects the measurements, stores them, and can then export the measurements into an excel document. The graph shown on the screen in Figure 7 is the graph from an actuation, and all that data was also stored in an excel file and used to make the graph in Figure 9. In comparison, the graph in Figure 7 appears much noisier due to the vibration of the chemistry building. However, this vibration was fairly consistent, and excel's smooth curve function was used to create the less noisy graph seen in Figure 9.

Lastly, since a new calibrated laser was purchased, the stability assessment was no longer necessary. The MSA was also eliminated from the project because the instrument is currently only set up by a few trained people, and the instrument’s software program is making the measurements, recording them, and storing them. This means that there is very little human interaction to cause bias in the measurements. The control chart sent by Micro-Epsilon can be seen in Figure 6.

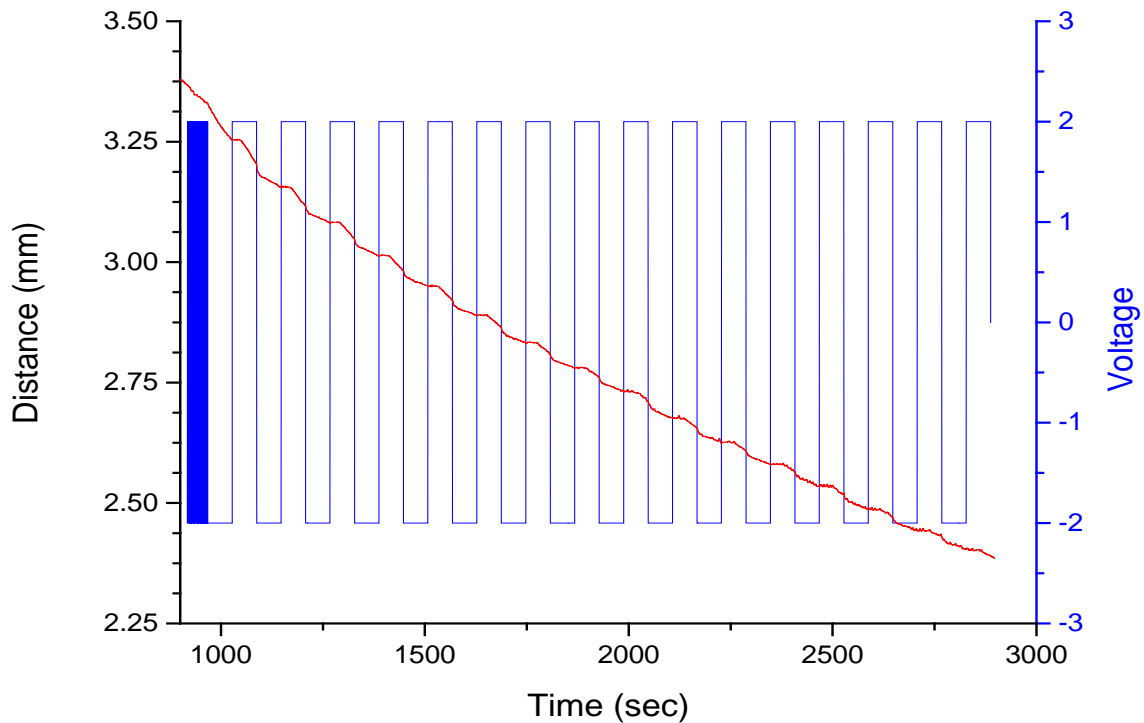
Figure 8: Distance (mm) and Voltage vs. Time (sec) graph from strain testing day 2 sample 3. Distance (in red) indicates the reading from the laser displacement meter during actuation (decrease in distance=elongation of actuator strip). Graph made by Nathan Bradshaw.

Strain data for two different samples can be seen in Figures 8 and 9 which show the distance measurements recorded by the laser displacement meter overlapped with the applied voltage. The data collected from the strain testing showed that the movements of the actuator strips were consistent with what was expected. When positive voltage was applied, the strips contracted. This movement was indicated by either a positive or approximately zero slope on the distance graphs (see Figures 8 and 9) meaning the strips either shrunk, or stopped elongating for a moment. The strongest contractions were observed in the first couple cycles of actuation which is likely due to the fact that the measured current of the strip decreases throughout out the actuation as the strip degrades. When negative voltage was applied the strips relaxed and elongated, indicated by a negative slope on the distance graph.

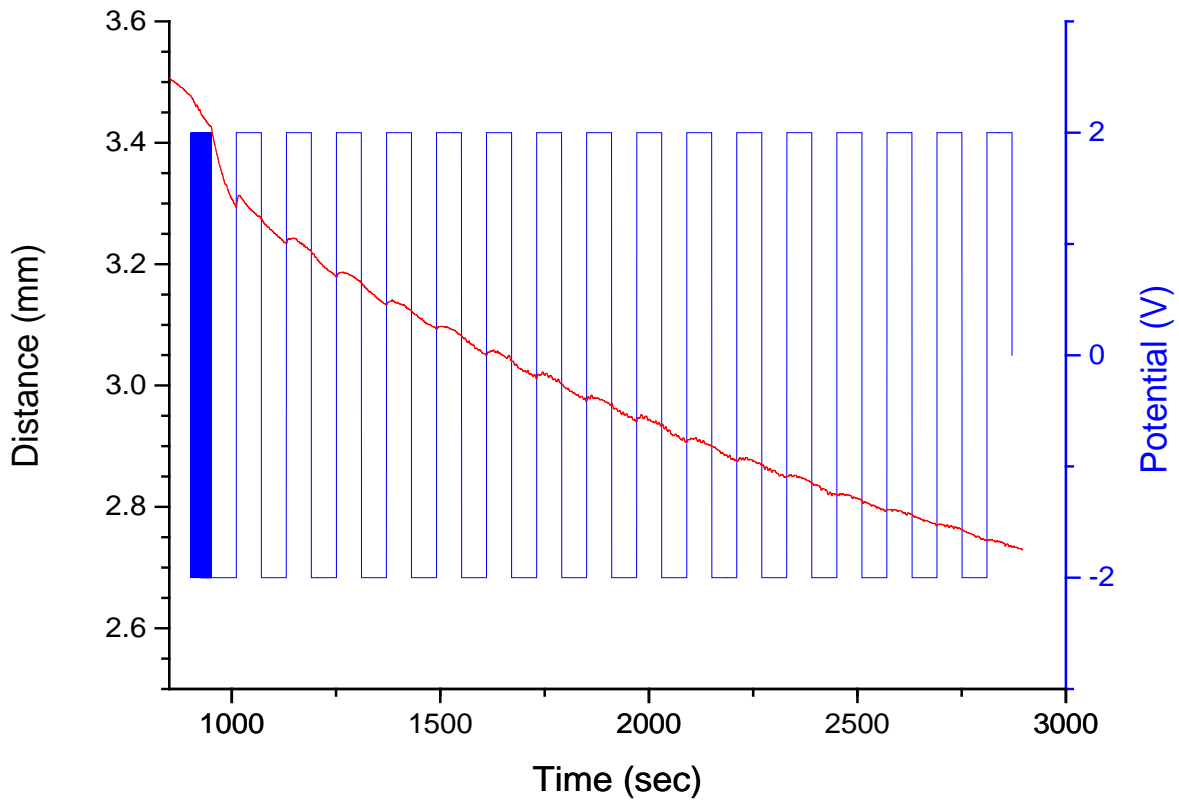
Figure 9: Distance (mm) and Potential (V) vs. Time (sec) graph from strain testing day 3 electropolymerized sample. Distance (in red) indicates the data from the laser displacement meter during actuation (decrease in distance=elongation of actuator strip). Graph made by Nathan Bradshaw.

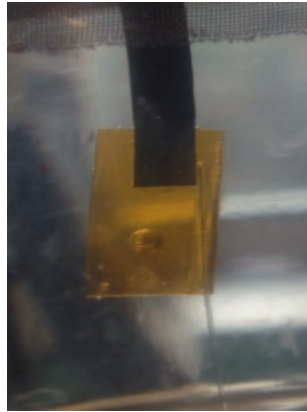
Figure 12: Fishing line w/out wire triangle

Another modification made to the original design was adding a metal triangular piece to the end of the fishing line that attached to the base of the actuator strip (see Figure 13). The first couple of times the instrument was set up it was difficult to place the fishing line perfectly in the middle of the strip in order to provide even tension (see Figure 12), so a triangular piece of wire was attached to the fishing line in order to make it easier to assemble and to apply a more evenly distributed load.

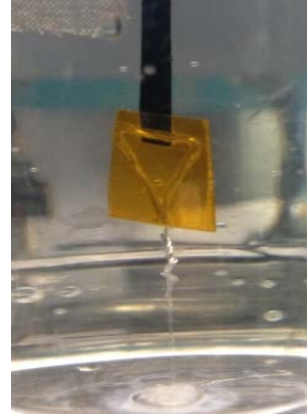
Figure 13: Fishing line w/ wire triangle
