A Comparison of the November 1990 and November 1995 Floods along the Main Stem Nooksack River, Whatcom County, Washington

MASTER'S THESIS

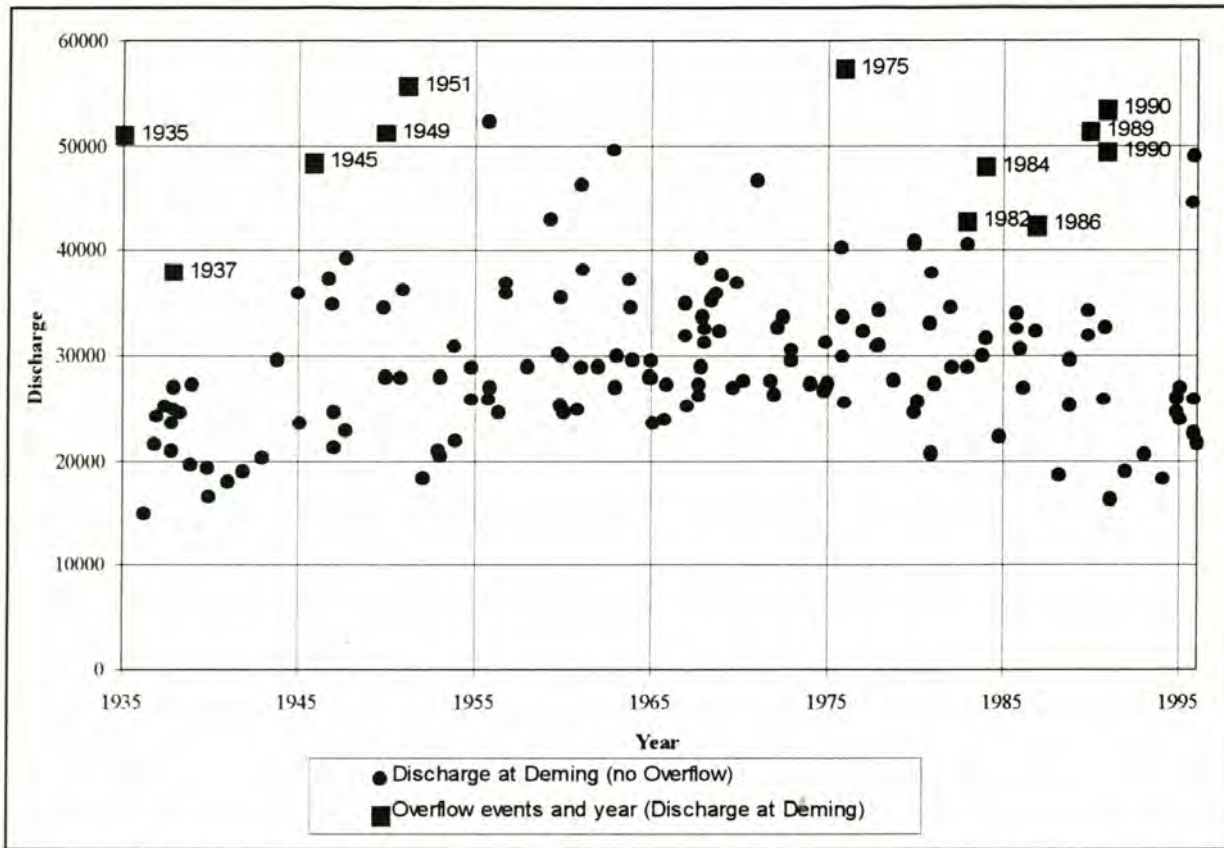
FIGURE 3: Historical floods at the Deming Gauge and Sumas Overflow events (adapted from KCM, 1995a and Appendix 1)

Figure 3 displays those past floods that have flowed down the Sumas Overflow. The natural and artificial restriction of the Nooksack River floodplain at Everson increases the potential for overflow events. [The floodplain narrows from an average width of 4,000 feet to less than 1,000 feet at the Everson Bridge.] Floodwaters slow and temporarily pond behind the constriction, slightly raising the surface of the water adjacent to the city of Everson and the low divide. When the surface of the Nooksack River reaches an elevation of approximately 88 feet at Everson, the drainage divide is overtopped (KCM, 1995b)

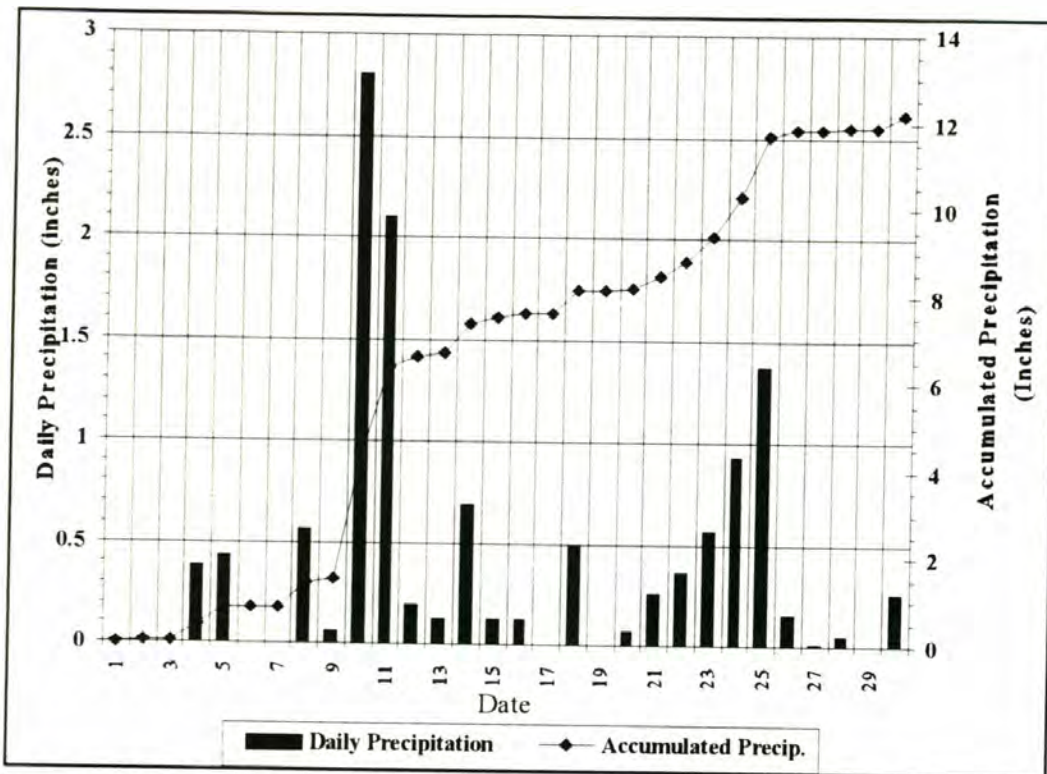
FIGURE 8: November 1990 precipitation at the Clearbrook Station (adapted from NOAA 1990c and *Bellingham Herald* 1-30 November 1990, p. A2)

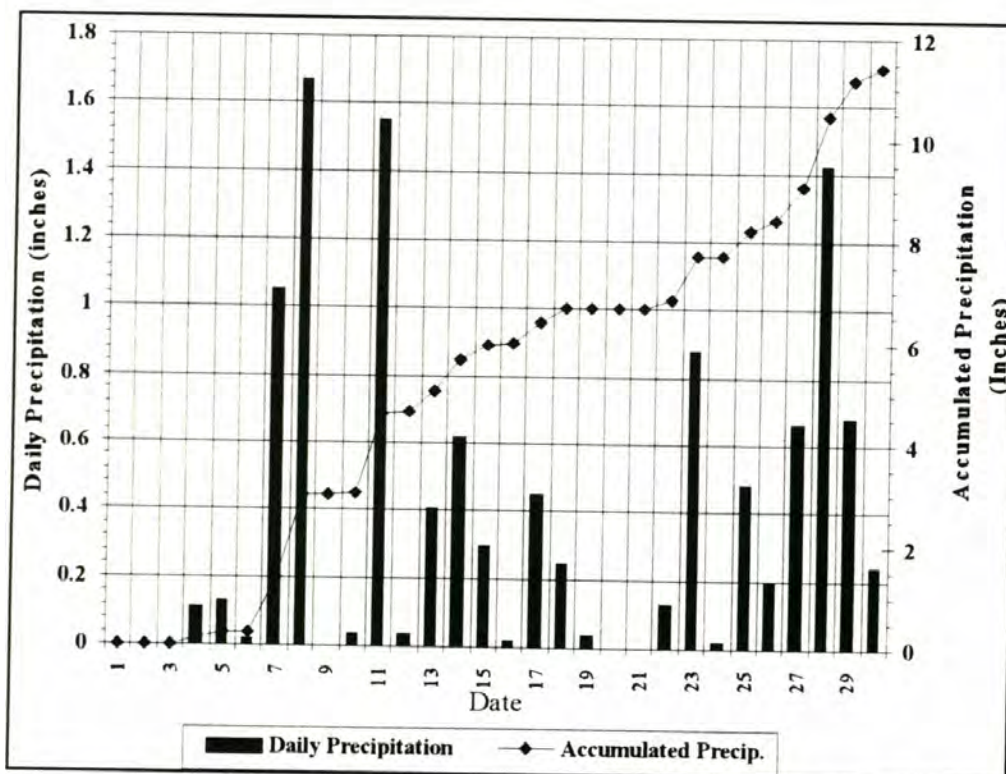
FIGURE 9: November 1995 precipitation at Clearbrook Station (adapted from NOAA 1995c,d)

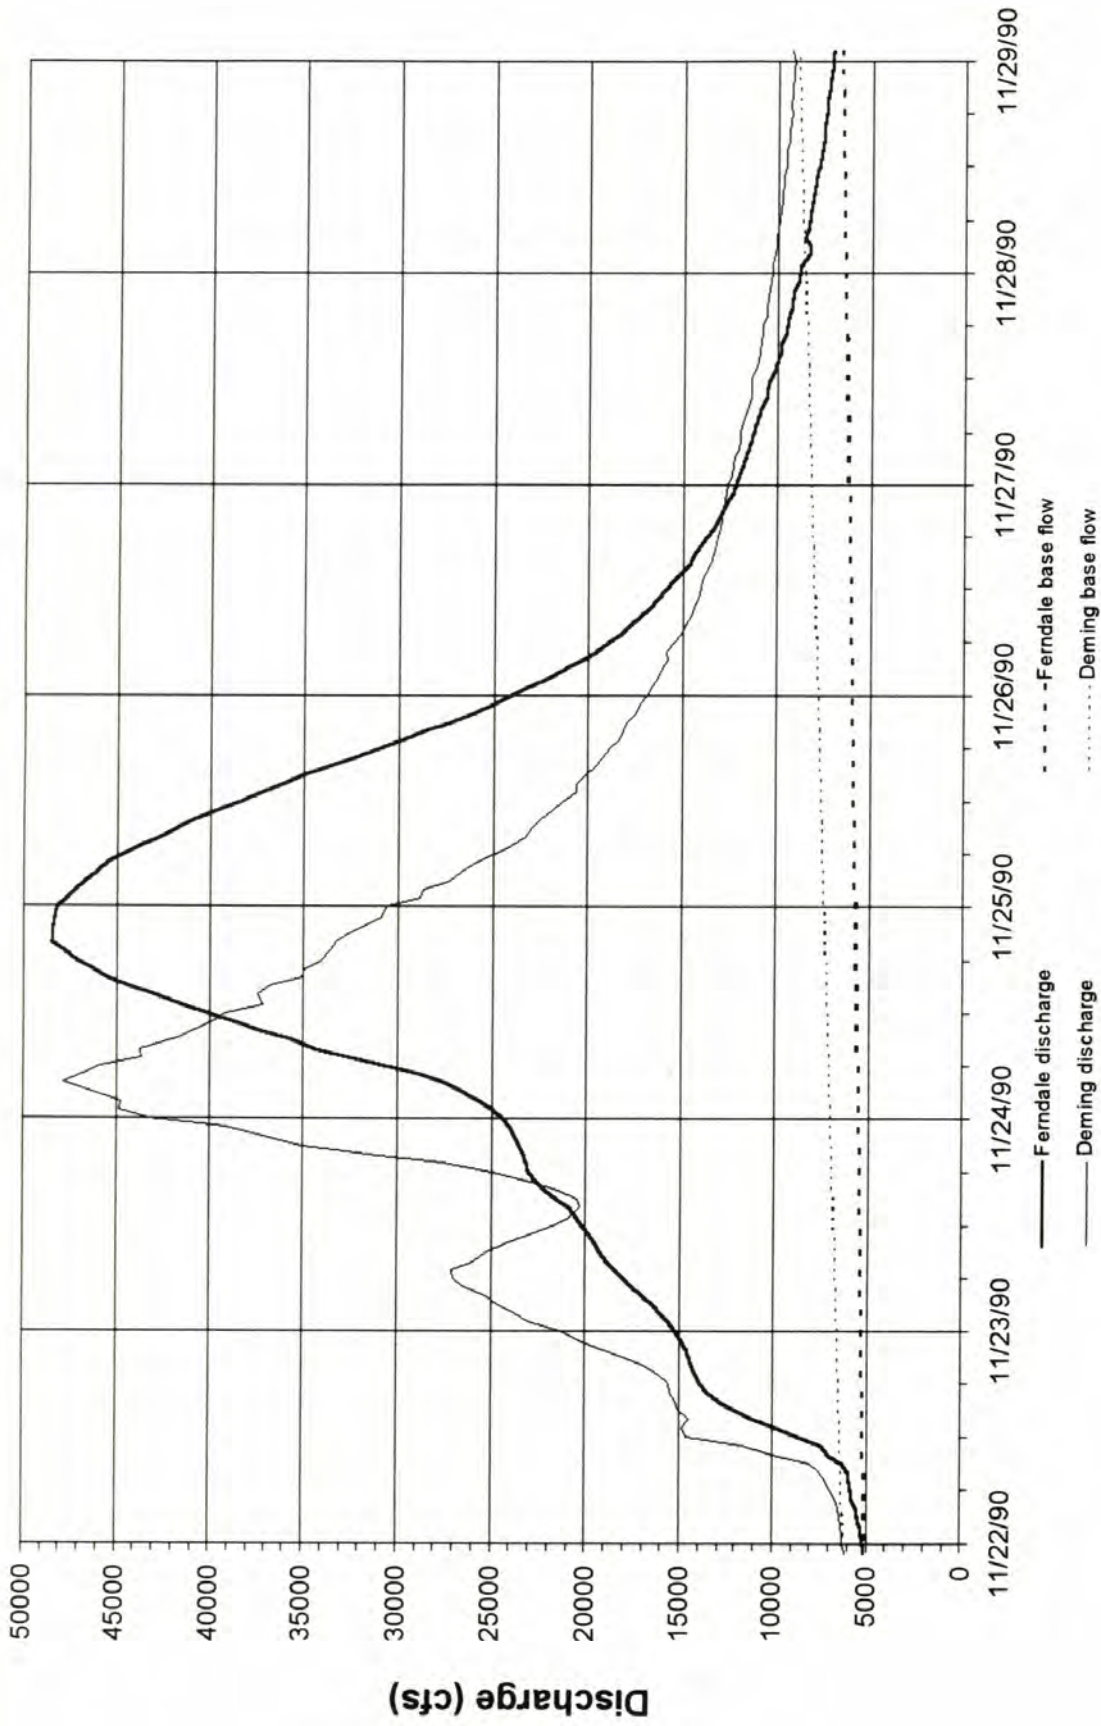
**FIGURE 11A: Ferndale and Deming Gauge hydrographs:
10 November 1990 flood**

**FIGURE 11B: Ferndale and Deming Gauge hydrographs:
24 November 1990 flood**

**FIGURE 11C: Ferndale and Deming Gauge hydrographs:
8 November 1995 flood**

**FIGURE 11D: Ferndale and Deming Gauge hydrographs:
29 November 1995 flood**

The shape of the hydrograph reveals information about the drainage basin. The data from the Deming Gauge commonly show two peaks a few hours apart (Figure 11). The flood peaks from each of the main stem's two major tributaries (the North and South Forks) reach the confluence at different times, resulting in two flood peaks at the Deming Gauge for each flood. The Ferndale Gauge usually shows a single peak for each flood, which is probably caused by the temporary storage and slowing of the first peak as it spreads out onto the floodplain. The second peak essentially 'catches up' with the first, resulting in one peak at the Ferndale Gauge. Another possible explanation for the dual peak at the Deming Gauge is that it is caused by the stream cross-section changing during each flood due to the highly mobile river bed at the gauge (details in Appendix 1). New stream gauges installed on each of the forks in 1995 and at Lynden in 1996 may provide the necessary data to test these hypotheses (Figure 7, page 17).

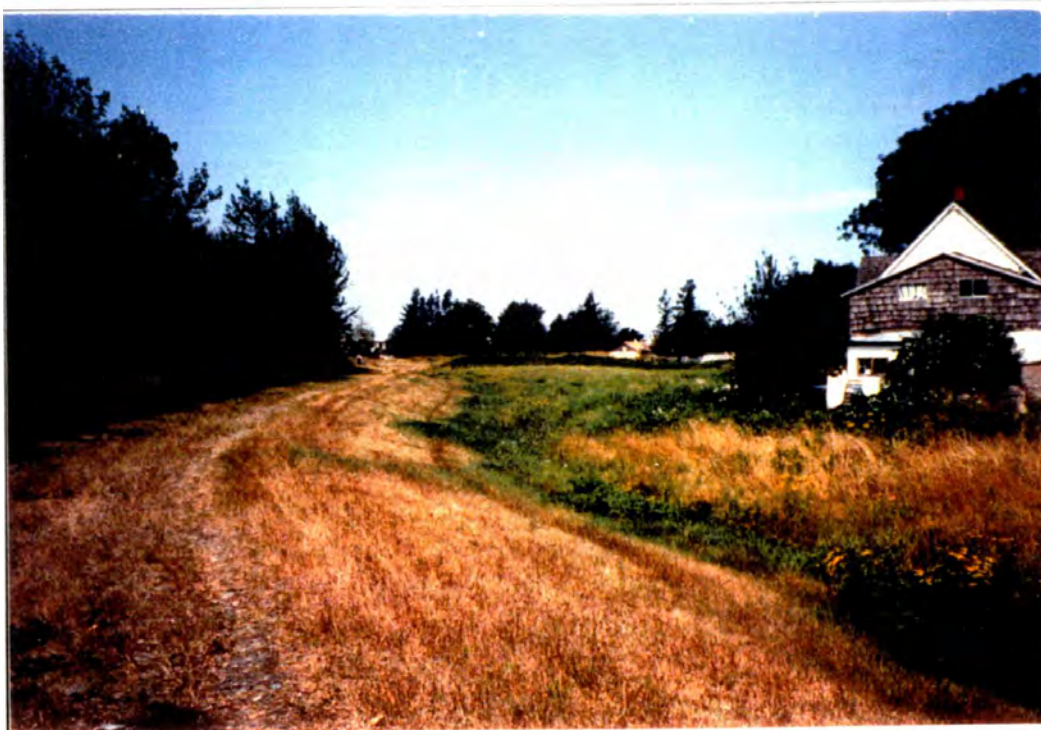
FIGURE 16: Everson Levee Extension at Everson (looking northwest). Project constructed 1991.

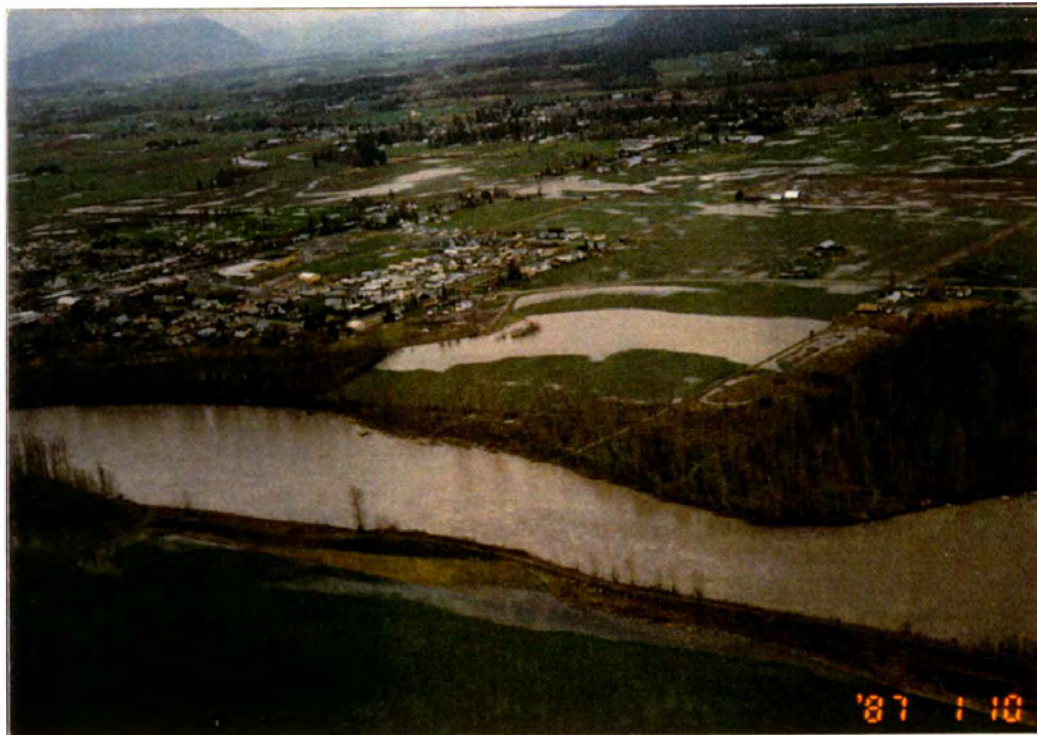
FIGURE 18: Back-flooded field (center of photograph) adjacent to the Everson Levee Extension. Nooksack River in foreground.
Photo date: 30 November 1995 (looking northeast)

The peak of the 29 November 1995 flood reached only as high as the bottom of the Everson Levee Extension (Figure 17). The floodwater elevation (84 feet) was not sufficient to overtop the levee at Everson. Even if the levee extension had not been constructed, the flood waters would not have inundated Main Street because the maximum elevation of the floodwater was not high enough to overtop the Main Street road grade. However, the Everson Levee Extension did save a few buildings from inundation during the 29 November 1995 flood, as can be seen in Figure 14 (north of levee extension). The field adjacent to the Everson Levee Extension was covered by floodwater that was deflected by the levee (Figure 18).

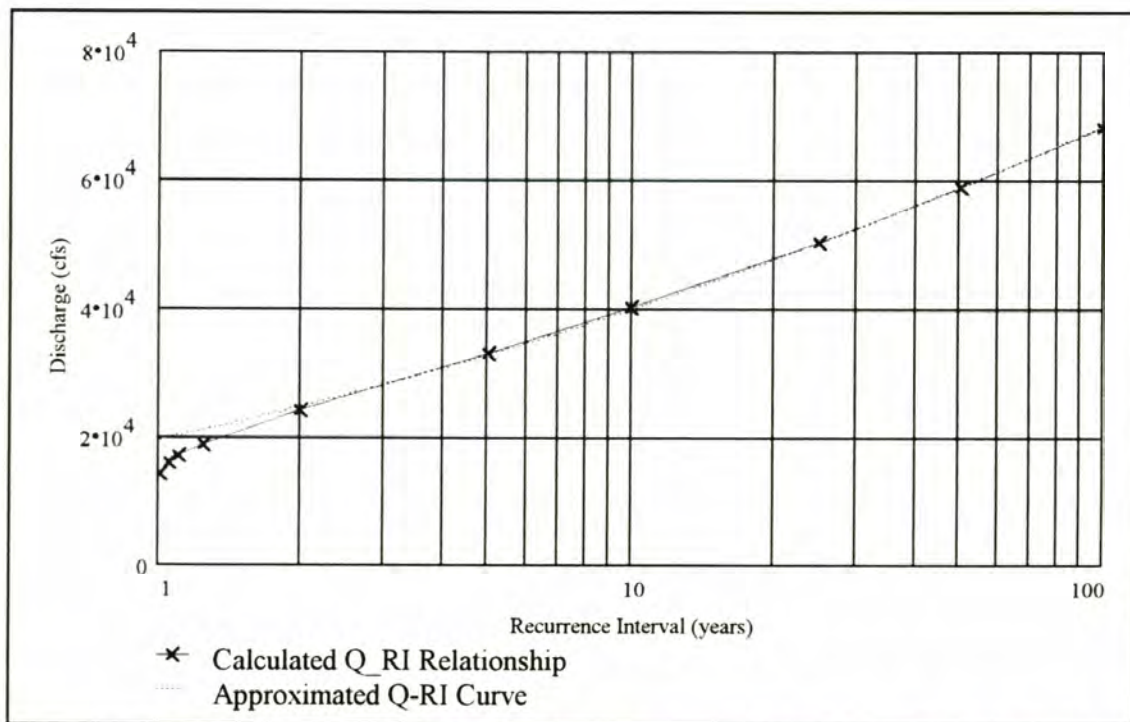
FIGURE Ib: Discharge - Recurrence Interval Curve for Floods at the Ferndale Gauge
