Assessing bulkhead removal and shoreline restoration using boat-based lidar

Overview

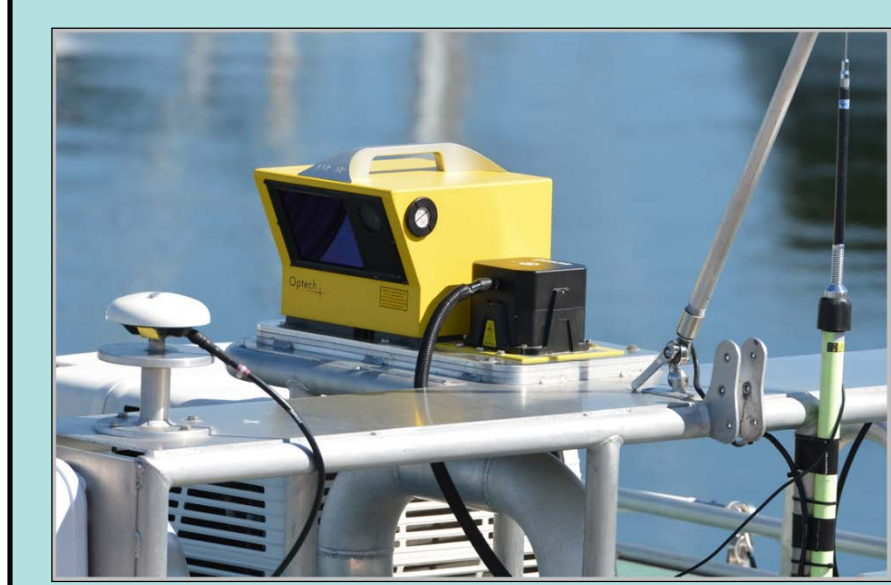
Data Collection

Boat-based topographic lidar surveys were conducted in Sept. 2015, about a year before removal of the shoreline armor, and June 2017, almost eight months following removal. Each survey involved the collection of boat-based lidar along 5 km of shoreline using Real Time Kinematic (RTK) corrections. Surveyors on foot set up lidar targets for ground truthing and collected photos for digital grain-size analysis. High-resolution shoreline photos were also taken during each shoreline scan to aid with point cloud cleaning.

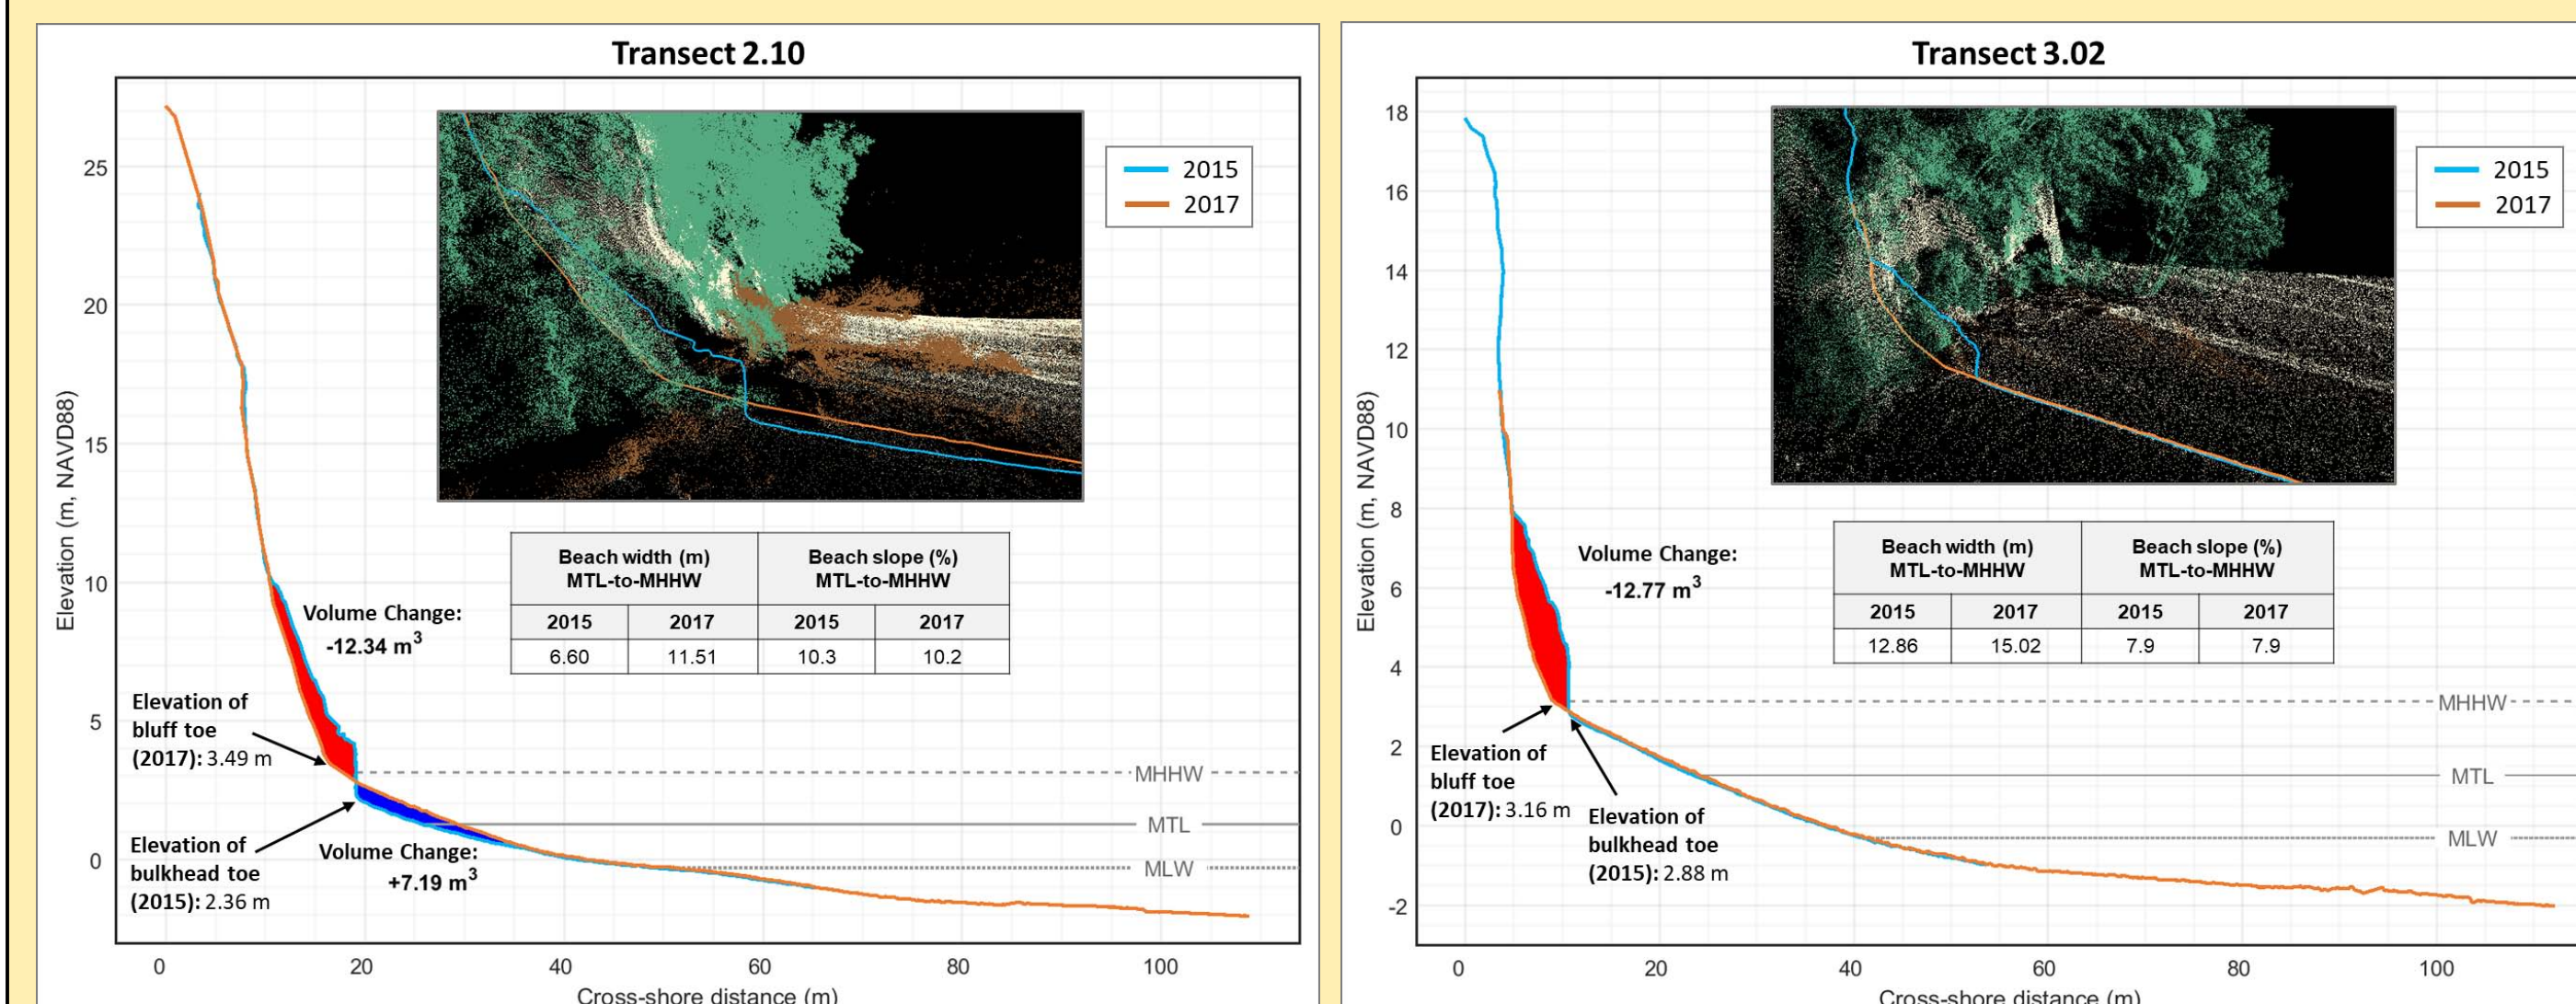
Cross-shore profiles

Profiles were extracted from the pre- and post-survey lidar point clouds and plotted together to show morphology and volume change.
