Elliott Bay Seawall Habitat Features – Initial Monitoring Results for Nearshore Ecosystem

Merri Martz
Anchor QEA, LLC, mmartz@anchorqea.com

Elliott Bay Seawall Innovative Habitat Design: Initial Results of Monitoring the Nearshore Ecosystem

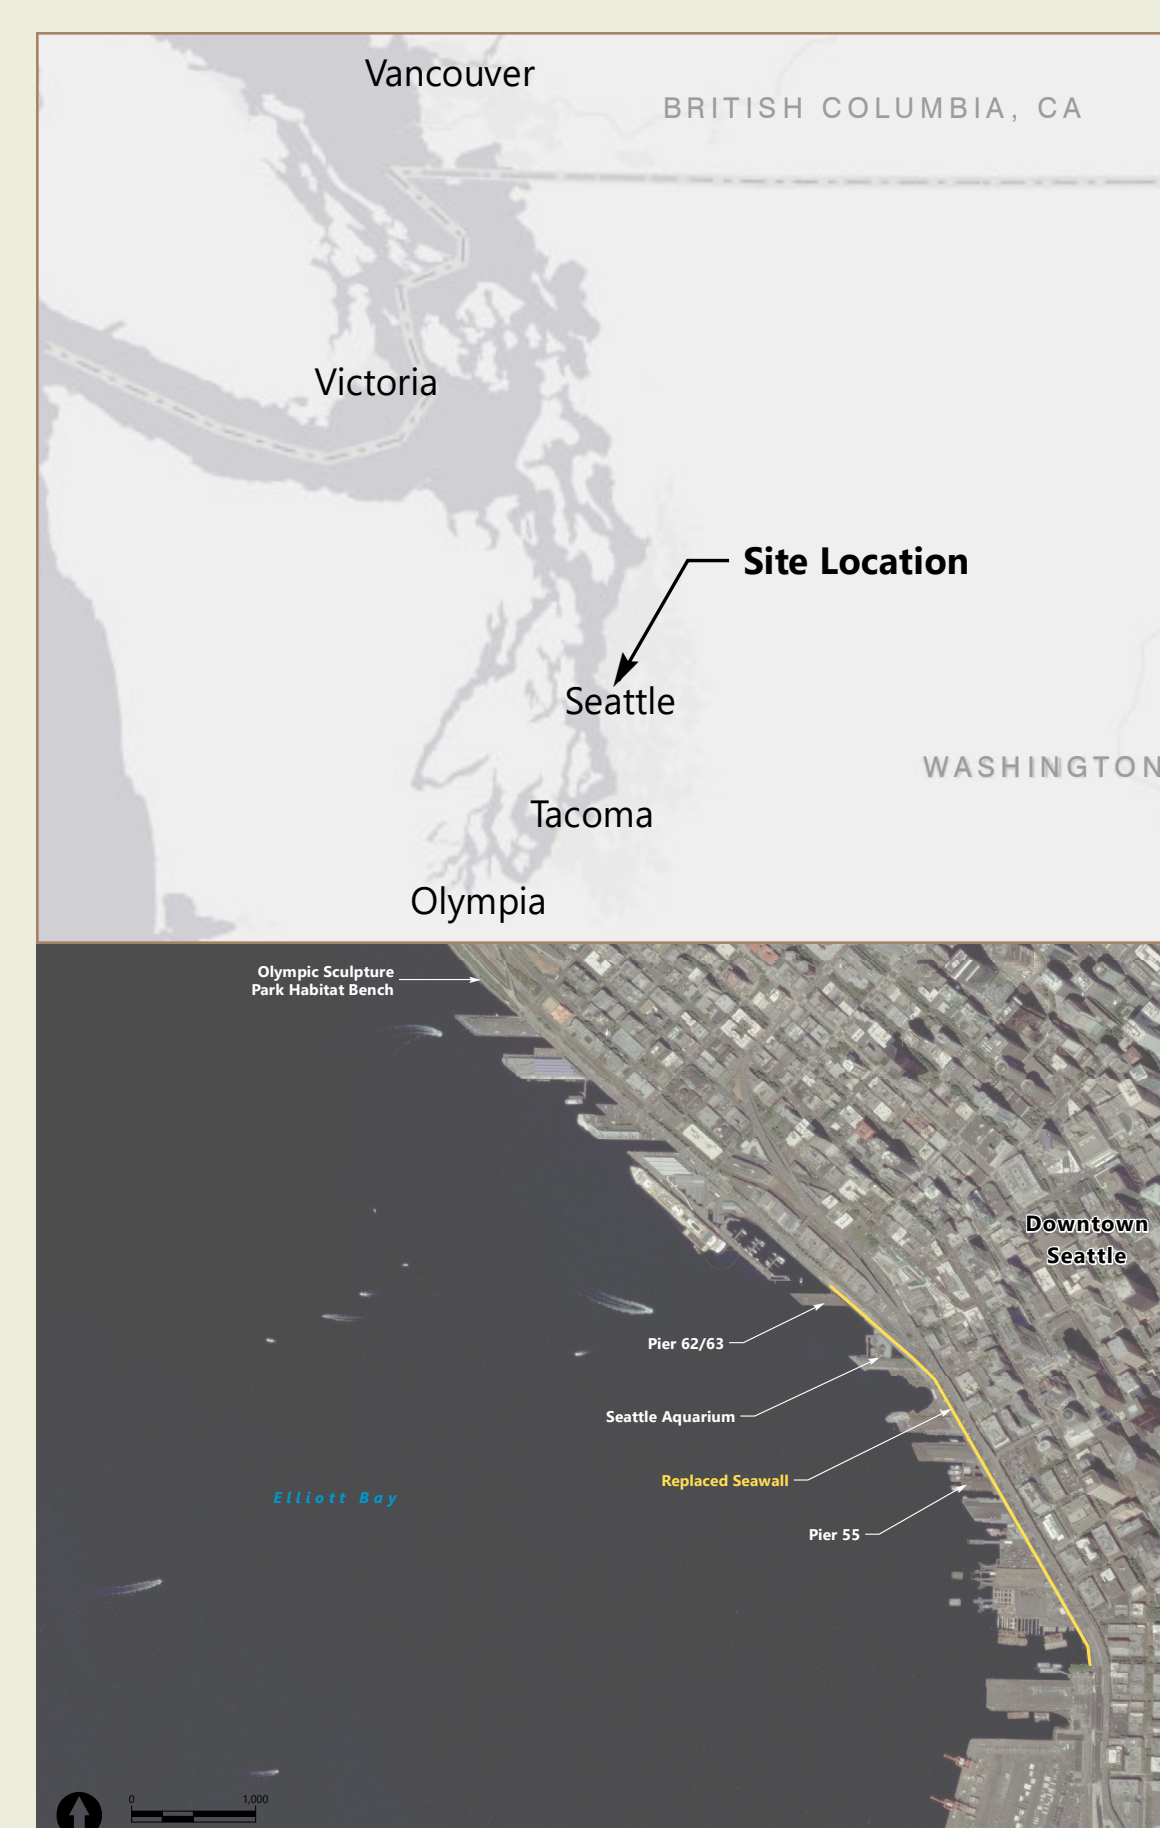
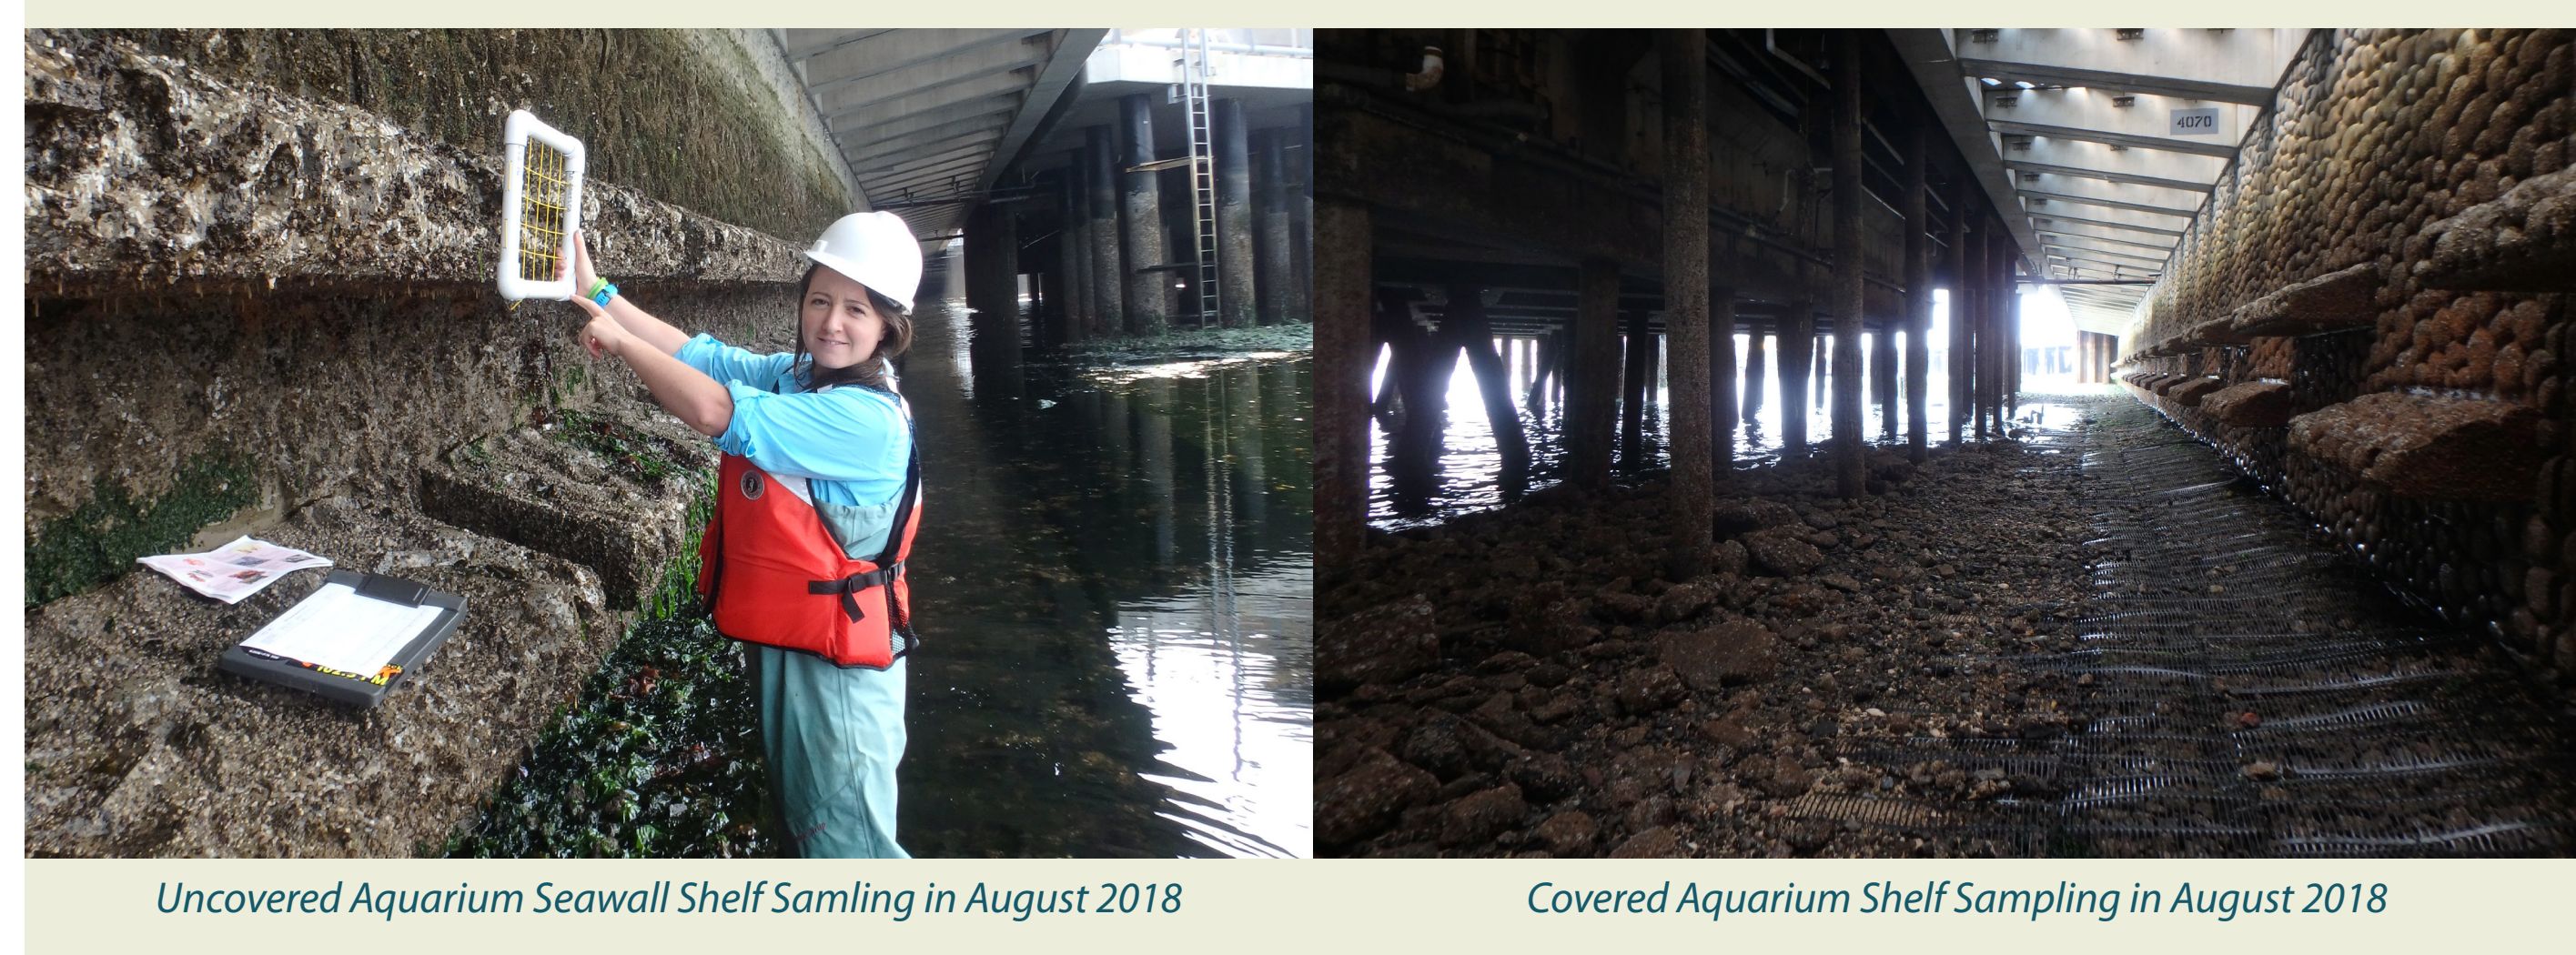
As part of the seawall replacement, several innovative habitat features were installed to improve the urbanized marine nearshore ecosystem: 1) light-penetrating sidewalks; 2) a textured seawall face with shelves; and 3) an intertidal habitat bench and beach.

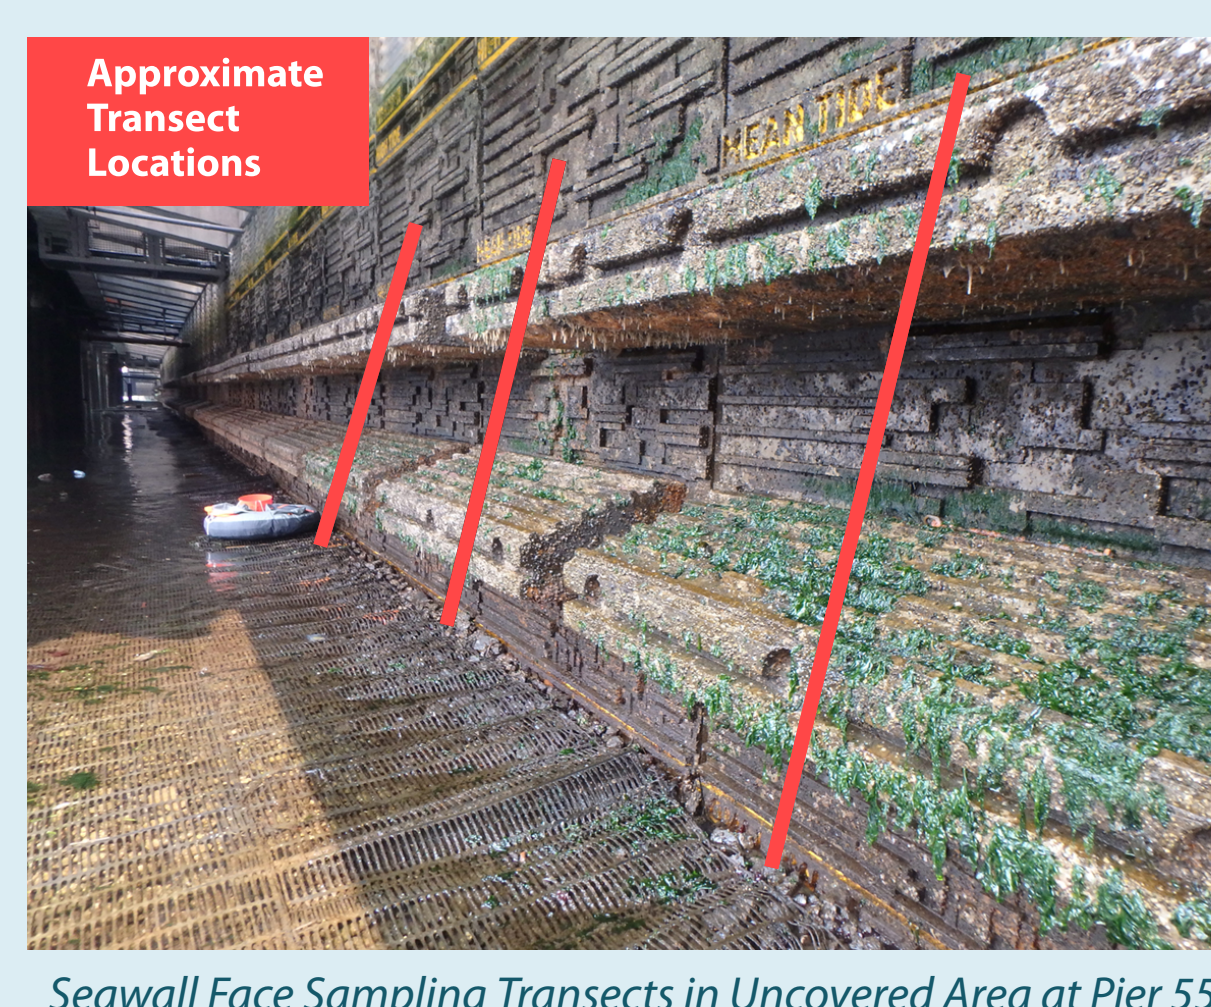
Invertebrate and Algal Attachment on the Textured Seawall

Sampling was conducted using quadrat sampling following the methods described in Goff (2010). Sampling occurred at two monitoring sites (Aquarium and Pier 55) in uncovered areas and behind piers at four elevations relative to MLLW.

All algae and invertebrates within quadrats were identified to species or family, and percent cover of the quadrat was recorded. Sampling occurred in April, June, and August 2018 during low tides.

Seawall Face Sampling Transects in Uncovered Area at Pier 55

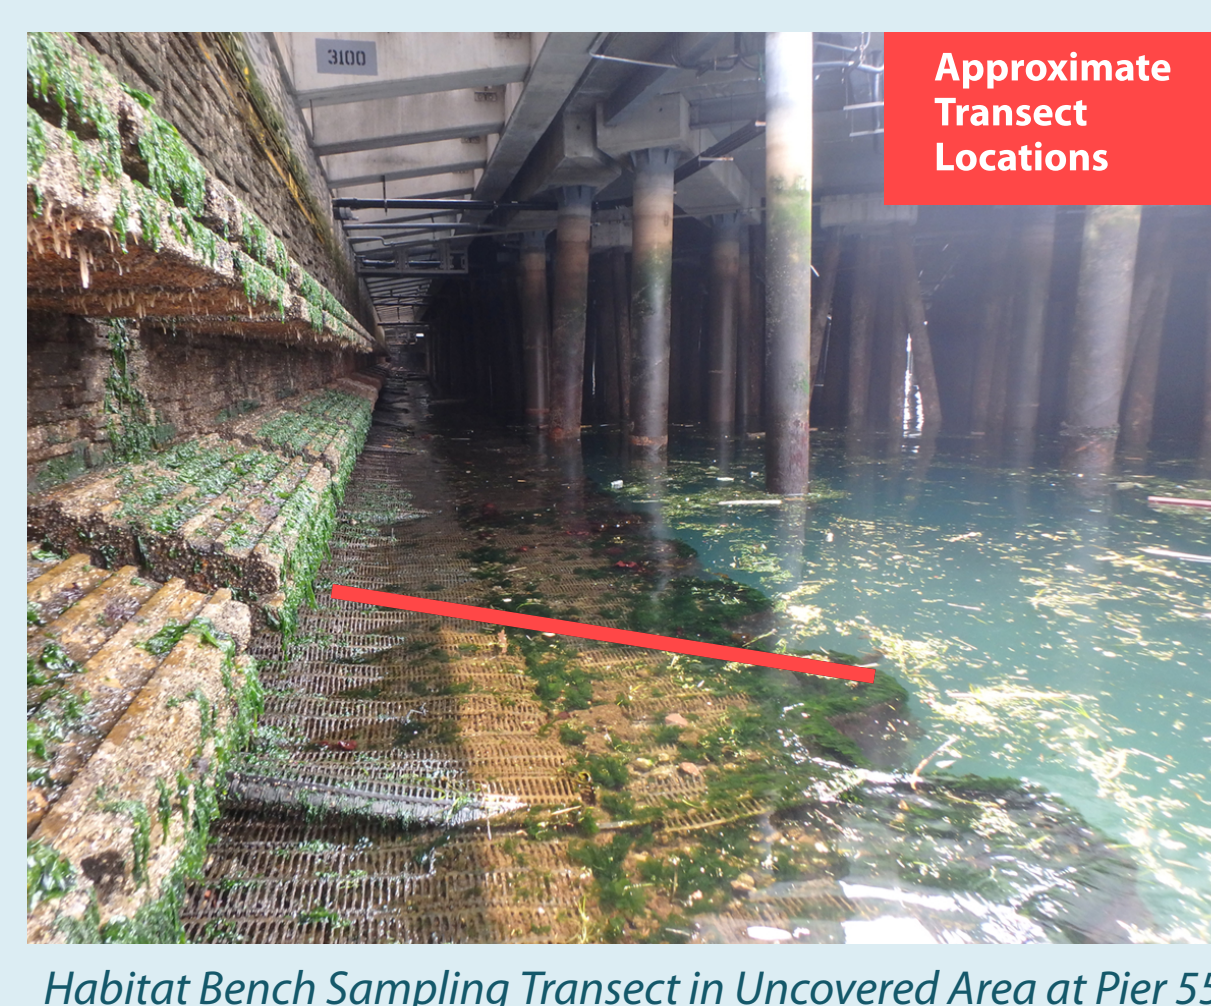
Macroalgae Growth Under the Light Penetrating Sidewalks

Sampling was similarly conducted following the methods described in Goff (2010), but only documenting macroalgae species/families. Sampling occurred at the same two monitoring sites (Aquarium and Pier 55) in uncovered areas and behind piers, but on the intertidal bench. Sampling was conducted in August 2018.

Habitat Bench Sampling Transect in Uncovered Area at Pier 55
