Marine shoreline armor mapping, change analysis (2009-2019) and regulatory compliance and effectiveness assessment for San Juan County, Washington

Marine shoreline armor mapping, change analysis and regulatory review for San Juan County, Washington

Tina Whitman, MS
Science Director

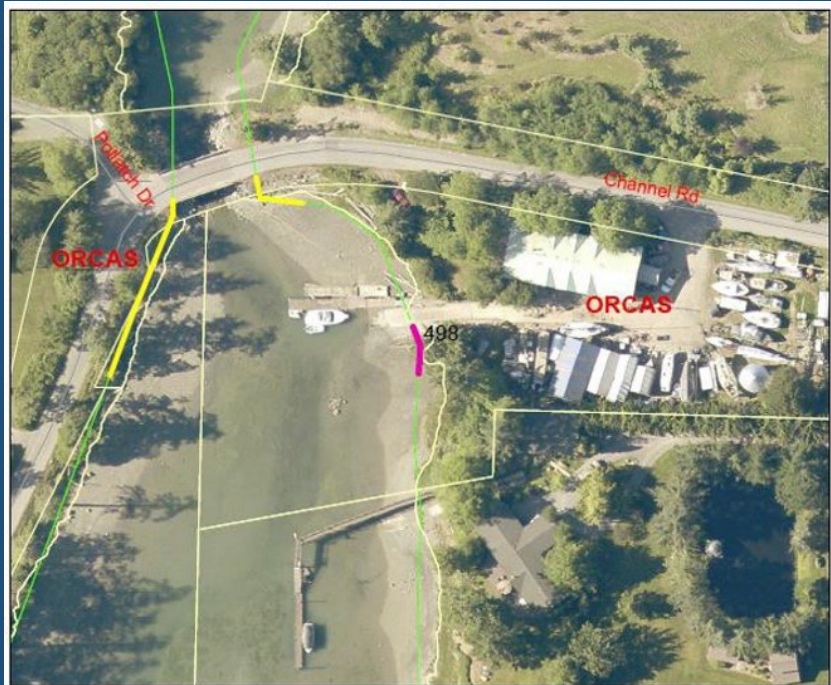
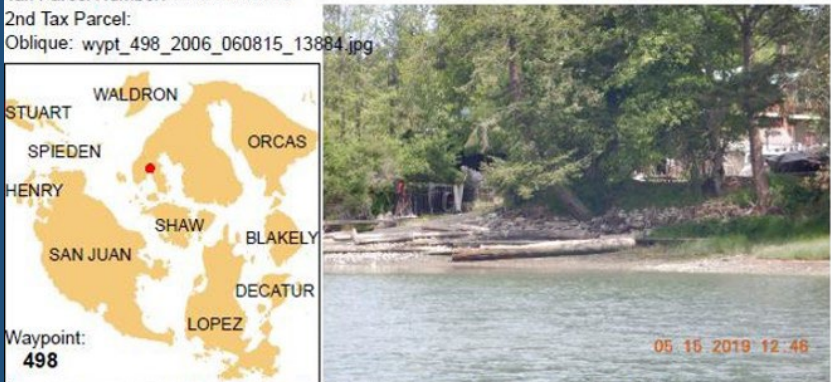
ISLAND: Orcas Mapped Length: 36.19
Tax Parcel Number: 260724003000
2nd Tax Parcel:
Oblique: wypt_498_2006_060815_13884.jpg

Boat based survey of armor location, extent, condition, tidal elevation, material and association.

Review of 2009 and 2019 survey images and data, oblique and vertical air photos, field re-visit to identify all Existing, New, and Removed Armor 2009-2019.

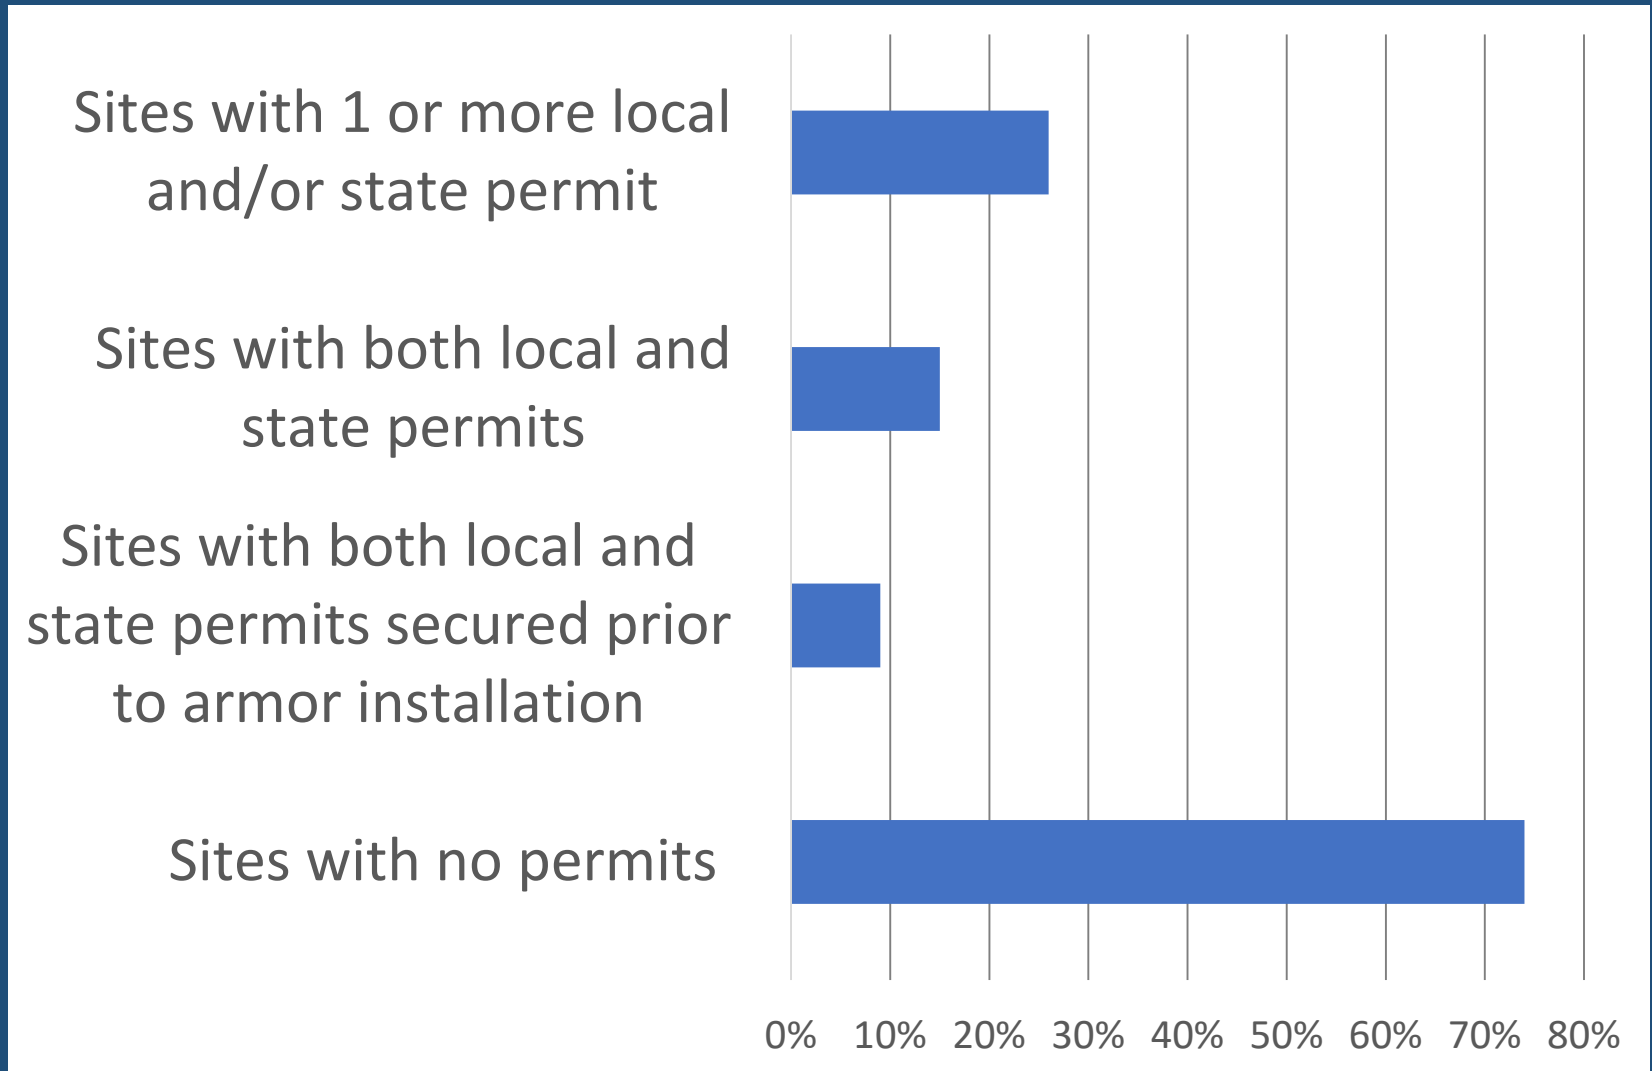
Regulatory Review Results - *Compliance*

Permits	Count	Percent
Sites with 1 or more local and/or state permit	28	26%
Sites with both local and state permits	16	15%
Sites with both local and state permits secured <i>prior</i> to armor installation	10	9%
Sites with no permits	80	74%
