Mechanical Testing of Artificial Muscles

Senior Project Implementation 2014

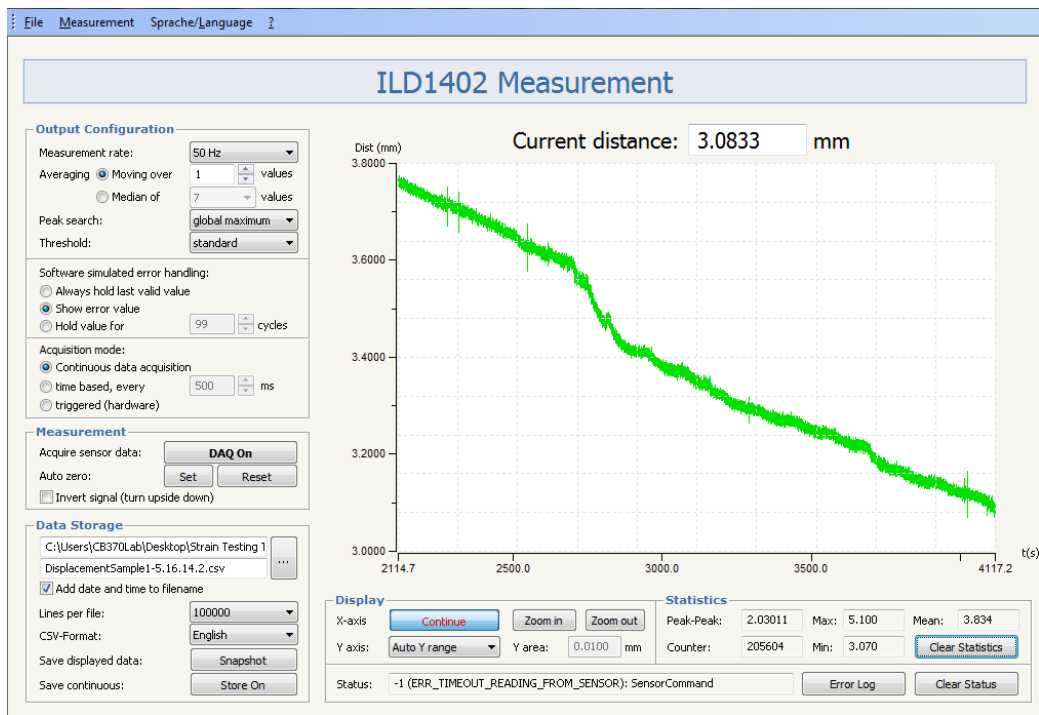
Figure 7: Screen shot of laser measurement software.

Due to the complicated setup and wiring of the laser displacement meter, this step of the project was completed by Nathan Bradshaw. Once this was done, the laser was ready to be incorporated into the rest of the assembly. The laser came with a software program that can measure, store, and export the displacement data into an excel file.

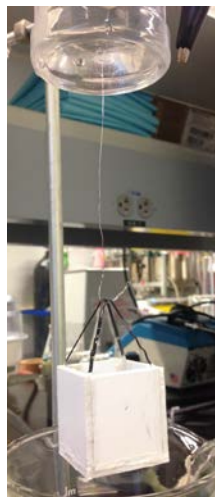
Figure 10: *Water tank hanging from wire*

Some modifications to the project were made during the course of the implementation period. First off, the initial design planned for a wire to suspend the water tank, however this was changed to fishing line due to kinking and bending of the wire that caused it to not hang perfectly vertical. The fishing line was a better fit since it did not kink and hung straight. Figure 10 shows the instrument

assembled with the wire that does not hang straight, and Figure 11 shows the instrument assembled with the fishing line that does hang straight.

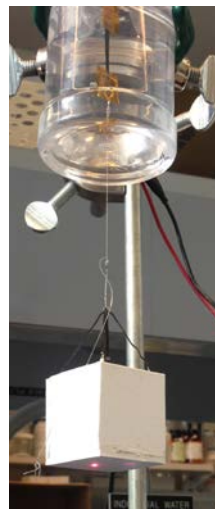
Figure 11: *Water tank hanging from fishing line*
