Fiberglass Composite Repairs Presentation

Fiberglass Composite Repairs

Brad Fenbert, along with Ian Saksa
Project Adviser: Dr. Tanveer Chawla

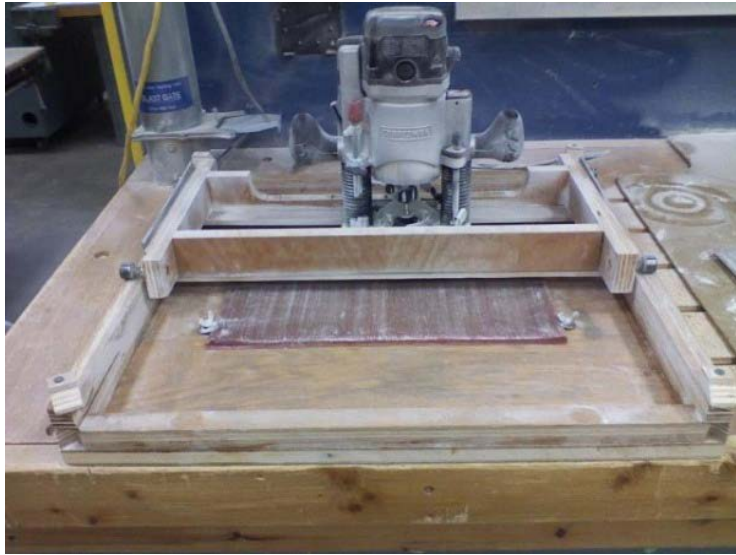
Figure 6. Grinding Setup

- Table frequently got stuck
- Grind depth would surpass router setting
- Table deflected in the middle
- Table accommodated 15.75" plates
- Relied on visual cues

- More consistent process, change apparatus so it doesn't deflect

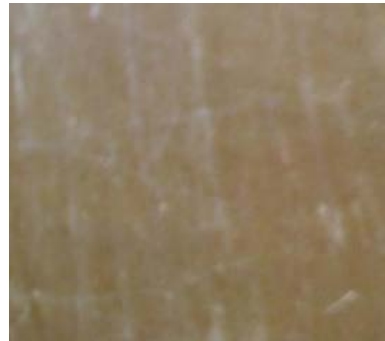
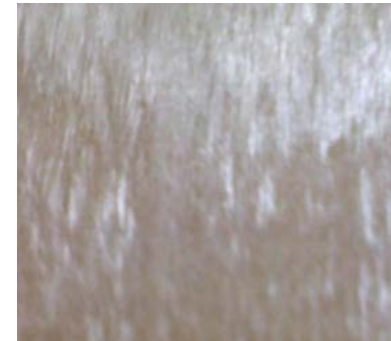
Figure 7. Full (left) vs half grind (right) surfaces

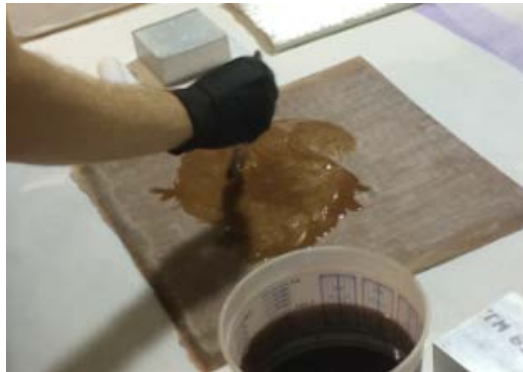
Figure 8. Cleaning plate surface

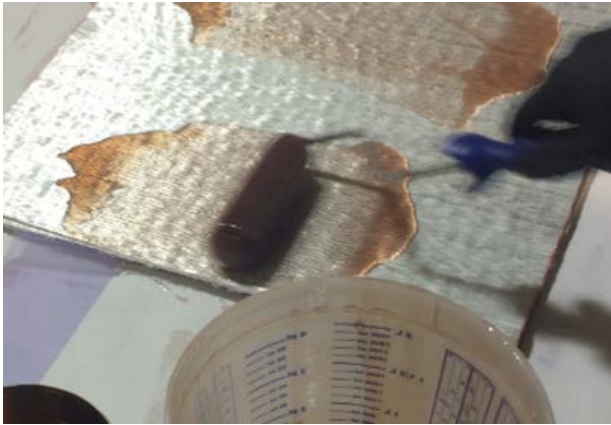
Figure 10. Foam roller for resin

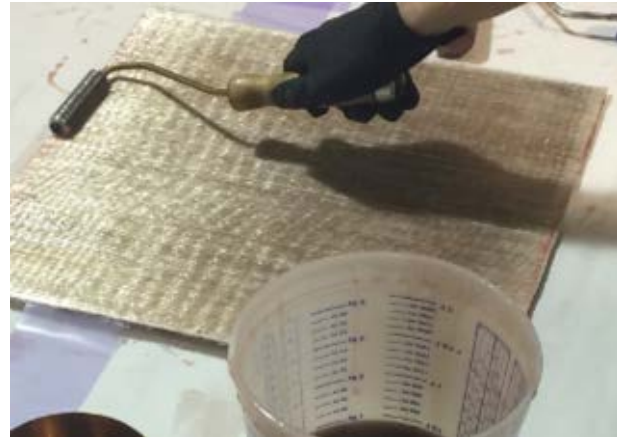
Figure 11. Metal roller for smoothing sheets

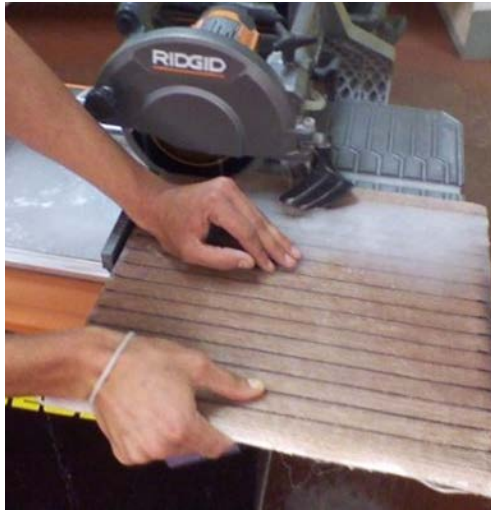
Figure 12. Cutting out specimens

- Table saw did not cut straight, laser alignment was off
- Difficult to cut hinges straight

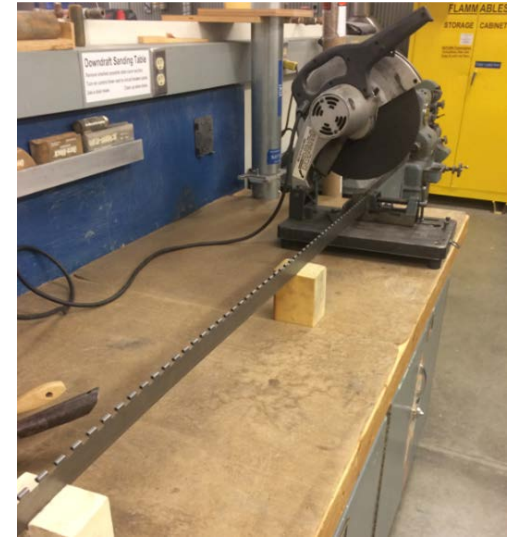
Figure 13. Cutting out hinges

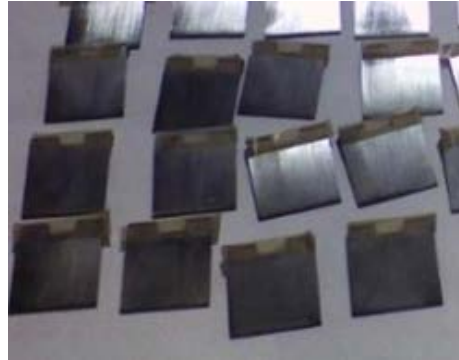
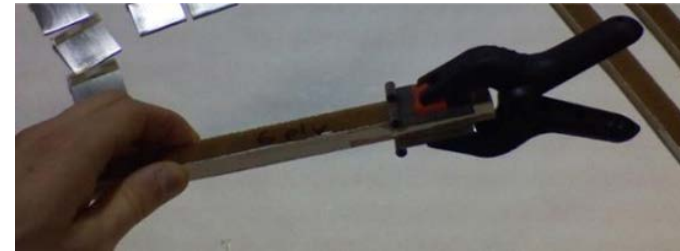
- Hinges were grinded, and teflon tape was added to allow consistent/even adhesive bonding surface
- Specimens were marked with white out and marked with fine tip ink pen marks to aid crack propagation/displacement measuring
- Hinges were adhered with methacrylate adhesive (Plexus MA300)

Figure 16. Hinge held by clamp

Figure 14. Roughed hinge surface

Figure 15. Teflon tape on hinges

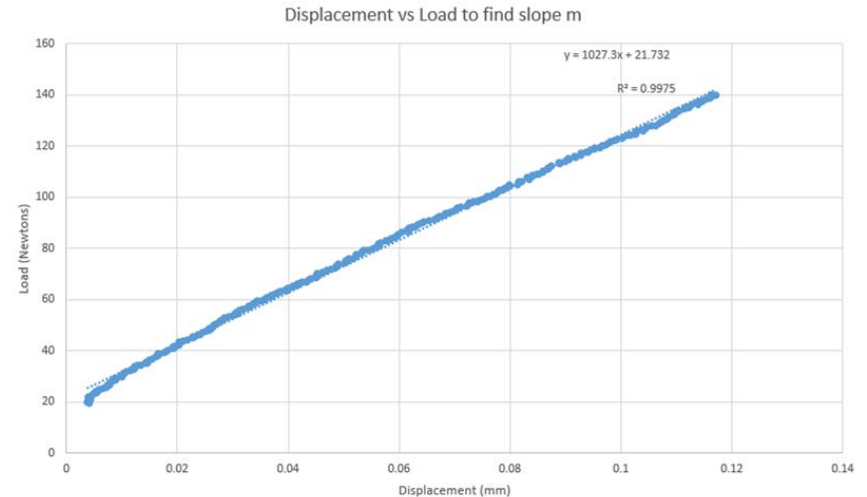
Figure 24. Refocused graph to determine slope of linear region (N/mm)

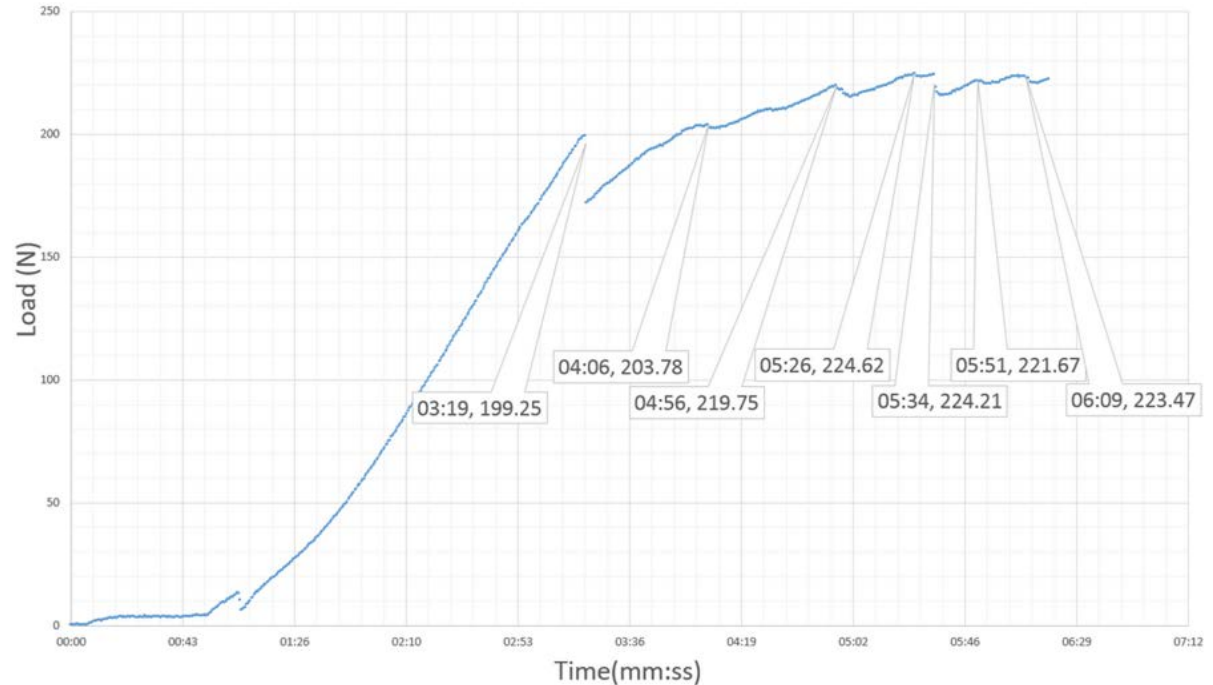
- Import MTS Data
- Sync Video & Load
- Record loads & corresponding crack propagations

Figure 25. Load vs time graph

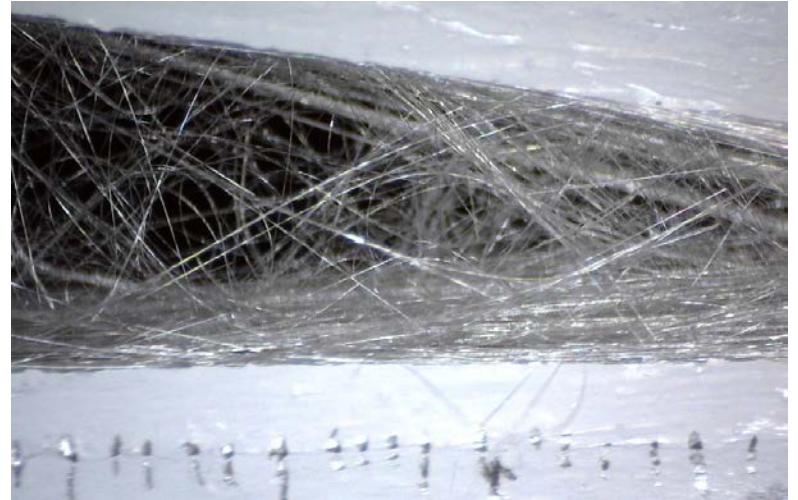
- Factors increased the amount of fiber bridging

Figure 34. Fiber bridging in Plate 5 (full grind, polyester) vs Plate 3 ($\frac{1}{2}$ grind, vinyl ester)
