## Mechanical Testing of Artificial Muscles

# Mechanical Testing of Artificial Muscles

Senior Project Implementation 2014

This document focuses on the design and fabrication of a low cost instrument to measure the strain of the artificial muscles being researched and developed by Dr. Amanda Murphy and her team at Western Washington University. The instrument utilizes a laser displacement meter to measure the movement of the artificial muscles during actuation. All project objectives and goals were successfully met, and all deliverables completed. Instrument quality and strain testing results are analyzed and recommendations for future work are suggested based on the results of the project.

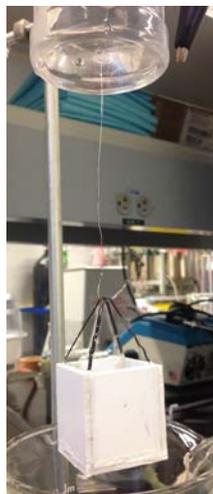
**Figure 10:** *Water tank hanging from wire*

Some modifications to the project were made during the course of the implementation period. First off, the initial design planned for a wire to suspend the water tank, however this was changed to fishing line due to kinking and bending of the wire that caused it to not hang perfectly vertical. The fishing line was a better fit since it did not kink and hung straight. Figure 10 shows the instrument

assembled with the wire that does not hang straight, and Figure 11 shows the instrument assembled with the fishing line that does hang straight.
