Elwha River restoration: evolution of habitats and nearshore ecosystems during large-scale dam removal project

Elwha Nearshore: An Overview

Seren Weber, Marisa Christopher, David Harvey, Anthony Thompson, Rylee Phillips
Coastal Watershed Institute & Peninsula College

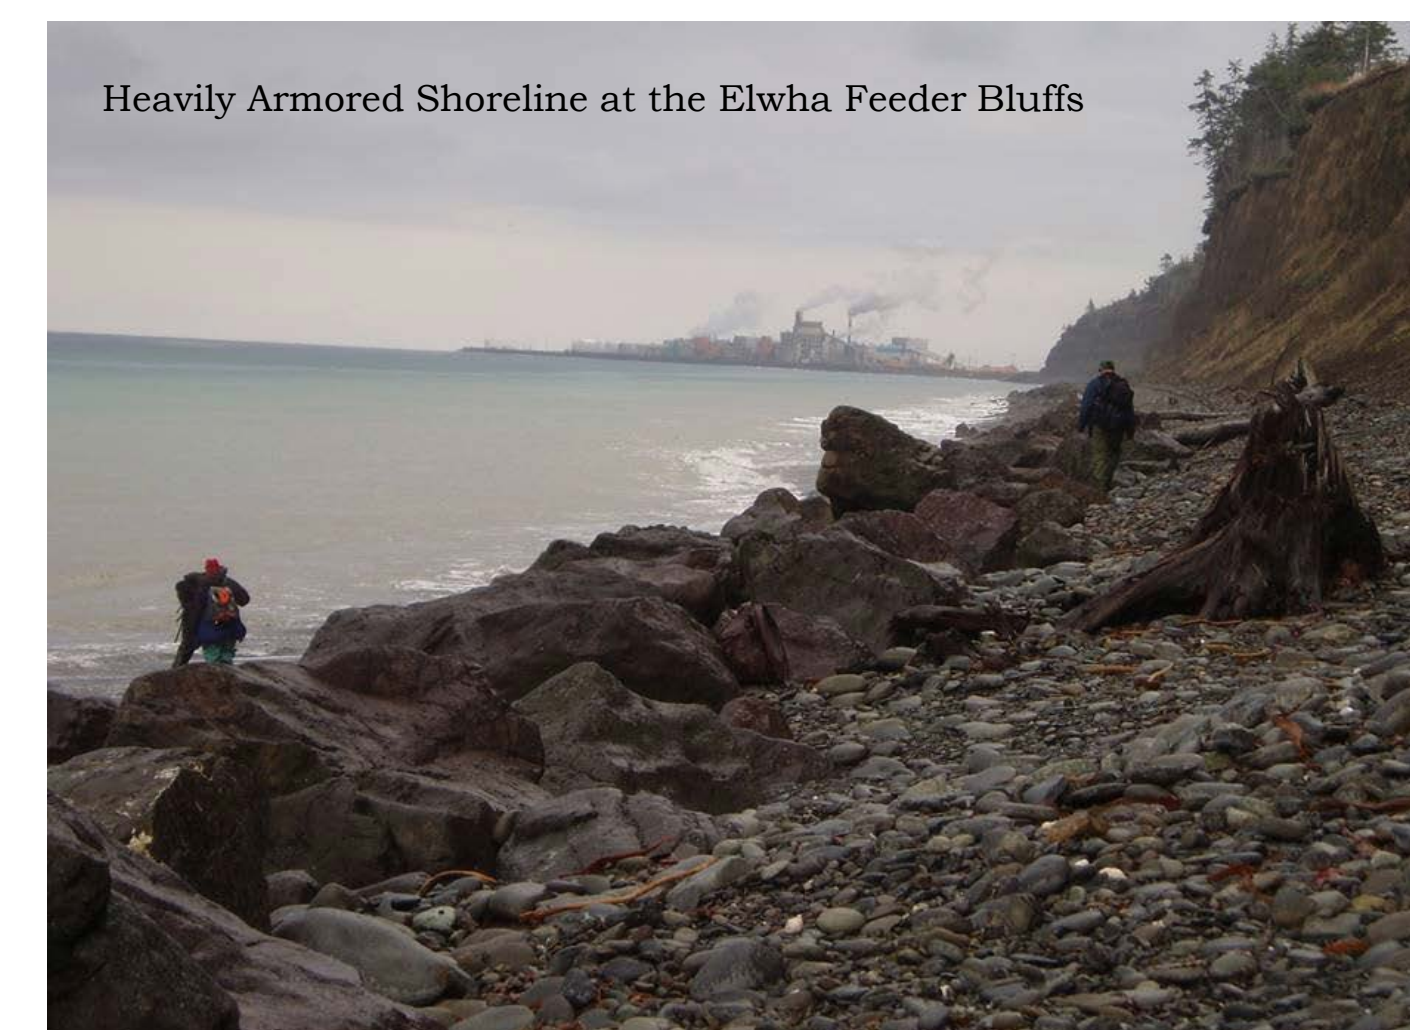
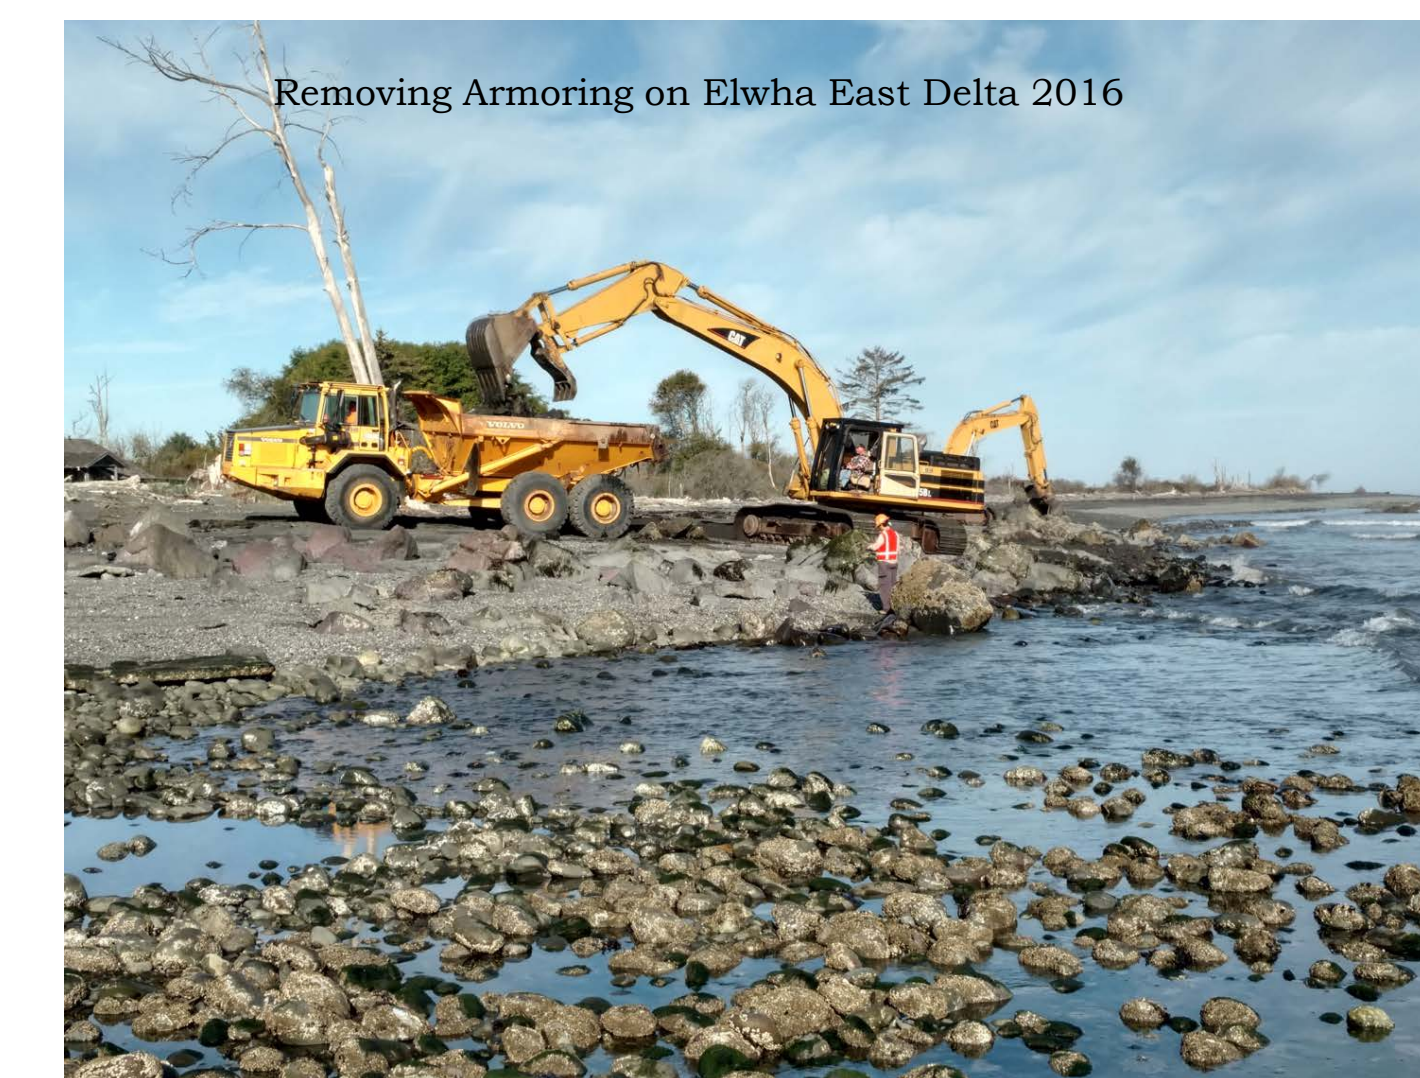
Anthropogenic Factors

Shoreline armoring and diking have been documented to inhibit deposition of sediment and large woody debris (LWD) along the Elwha nearshore (Rich et al. 2014, Lee et al. 2018). Removal of shoreline armoring and dikes has shown fast improvement in sediment deposition and restoration to forage fish spawning grounds (Lee et al 2018).

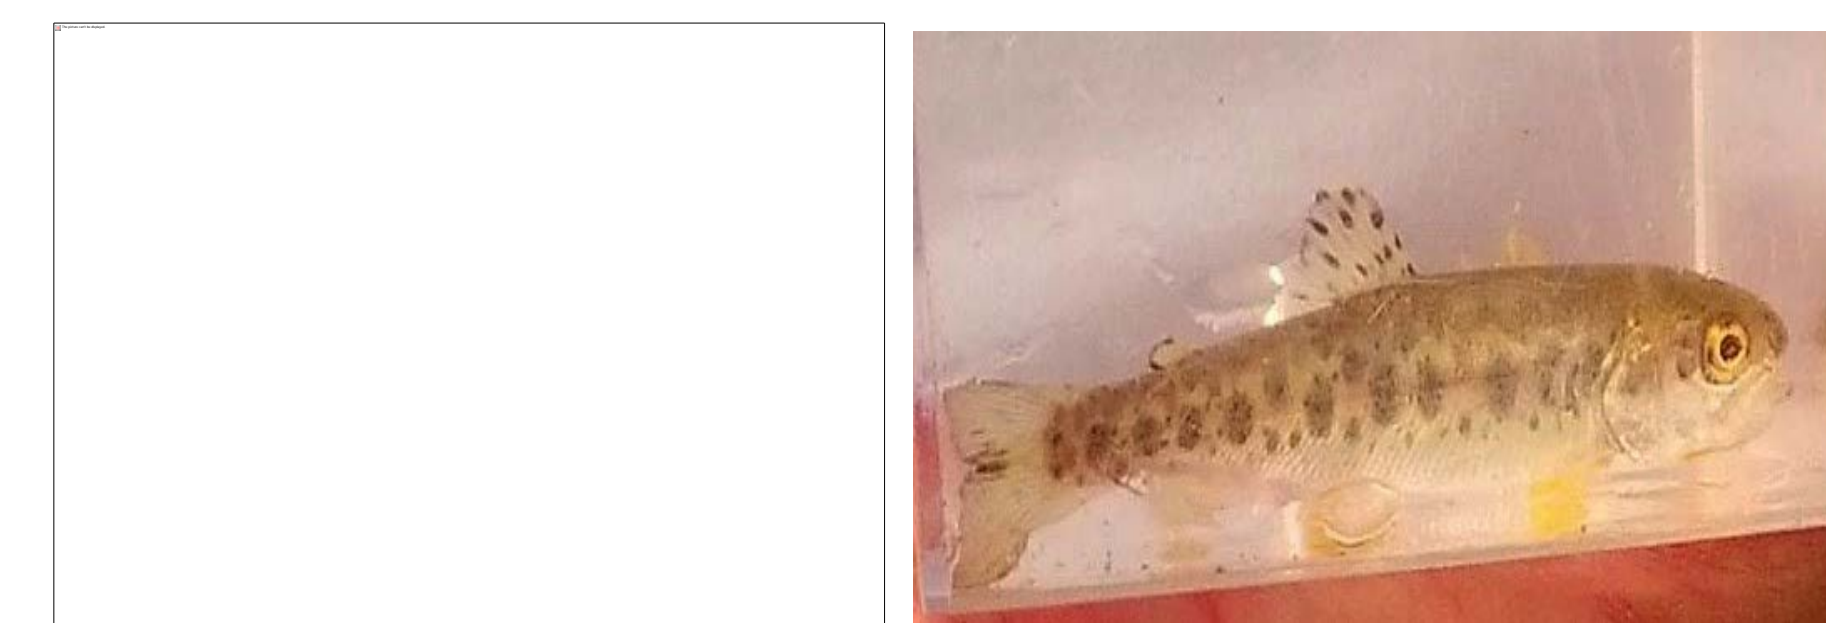
Sampling the Elwha nearshore 12 March 2015. Photo by Dave Parks and CWI. All Rights Reserved

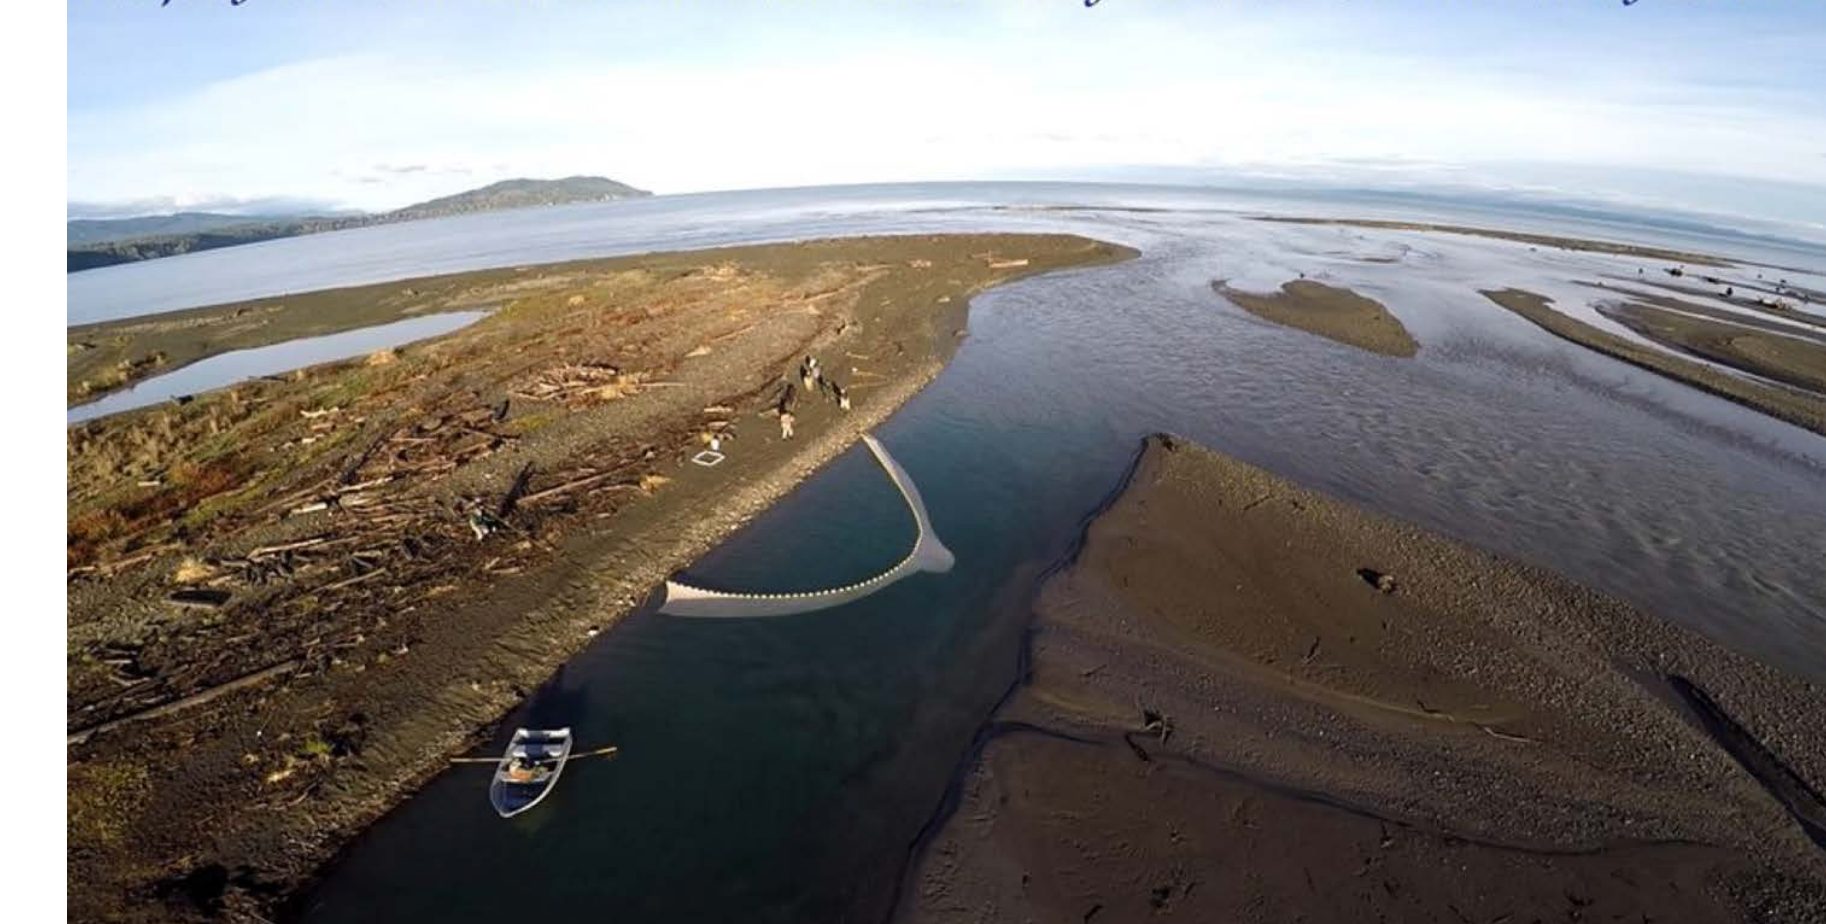
Prior to dam removals, 91% of salmon species used only 15% of Elwha estuary habitat (Shaffer et al 2009). Monthly beach seining continue in Elwha nearshore. Historic estuary is now lower river side channel, and new estuary habitat is being formed with sediment delivery to the river mouth.
